The Effects of Subsidence Resulting from Underground Bituminous Coal Mining on Surface Structures and Features and on Water Resources, 2003 to 2008

Bituminous Mine Subsidence and
Land Conservation Act

ACT 54 Amendments
Five-Year Report
August 2003 to August 2008

Research Conducted by the University
of Pittsburgh for the Pennsylvania
Department of Environmental
Protection

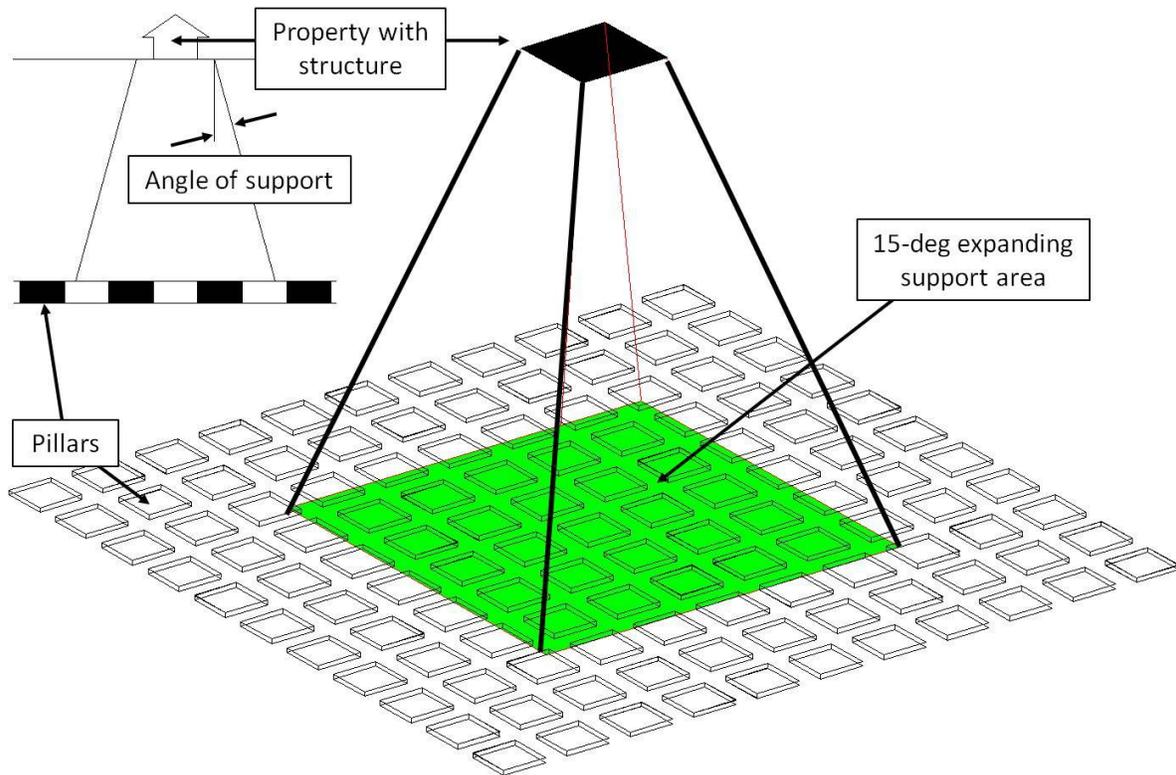
Figure I-1 – An interpretation of pillar support required by the BMSLCA (1966) to protect structures from subsidence damage (adapted from Gray and Meyers, 1970).

Gray and Meyers (1970) suggested that the area required underground to minimize subsidence damage on the surface was dependent on the selection of an adequate angle of support (Figure I-1). The angle of support was most dependent on the geologic character of the rocks and, in their report, varied from 15 to 25-deg. The net result required the support base at the mining level to increase between 53 to 93-ft along its horizontal axis with every 100-ft of overburden. The outcome was a support area at 500-ft of overburden, at least 3.4 times that needed at 100-ft. This method, while straight forward, did not accommodate changing geologic and mining conditions and, therefore, has been replaced by more advanced methods.

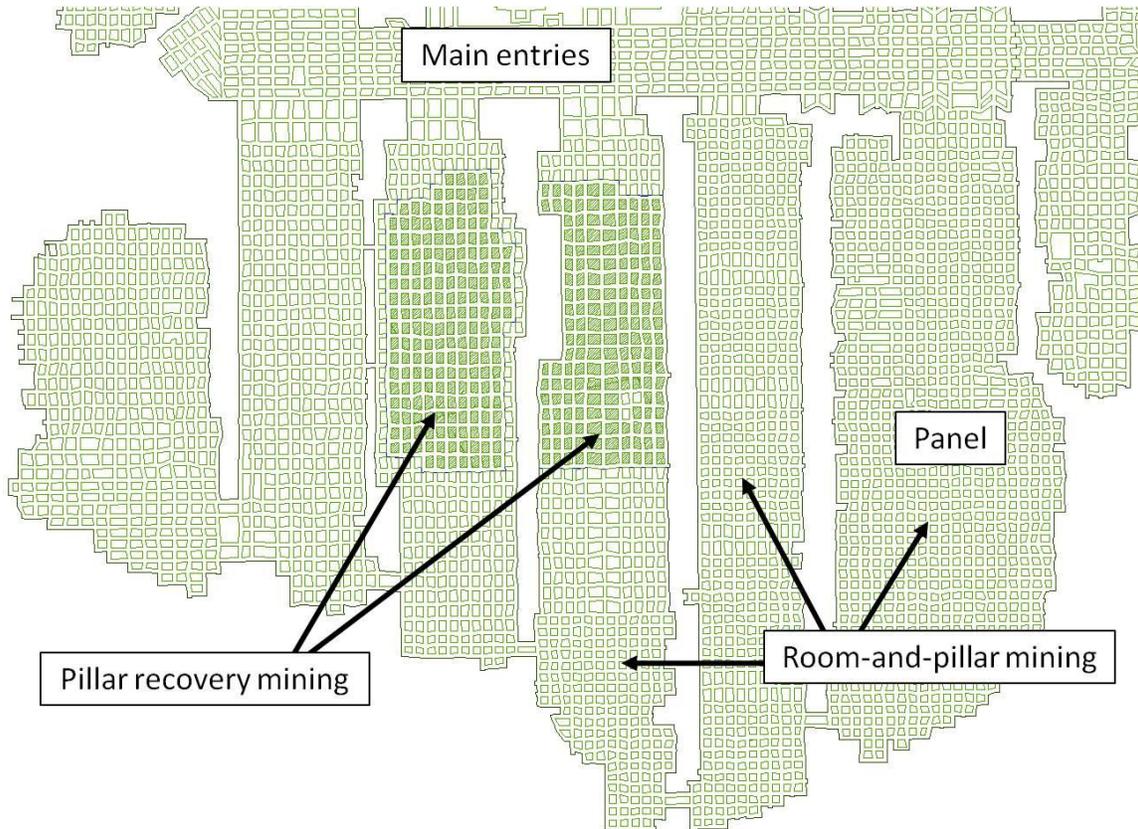
Figure I-2 - Example of a room-and-pillar mine where main entries provide long-term access to production panels. Six mines in Pennsylvania practice pillar recovery.

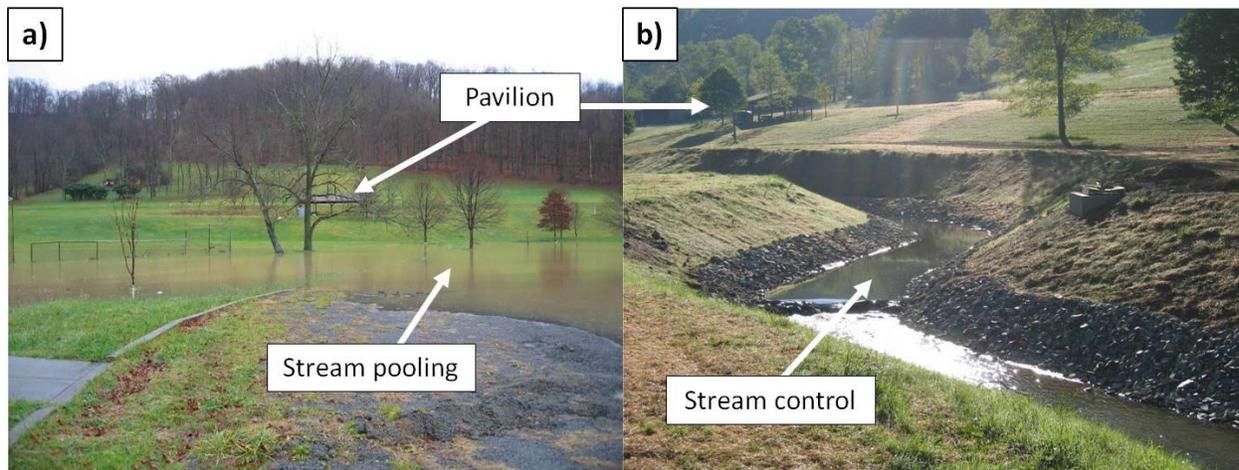
Figure I-5 - Photographs of a) stream pooling impacts to East Finley Township Park and b) coal company stream repairs to eliminate pooling and return the park to a functional state (Photograph from PA DEP files).

- Public infrastructure – Mitigation techniques are varied and depend on local circumstances. For example, the cost of rehabilitating interstate highways is paid for by the government. In other cases, coal companies repair and improve public recreation areas. Figure I-5 shows the East Finley Township Park before and after restorations made by a coal company.

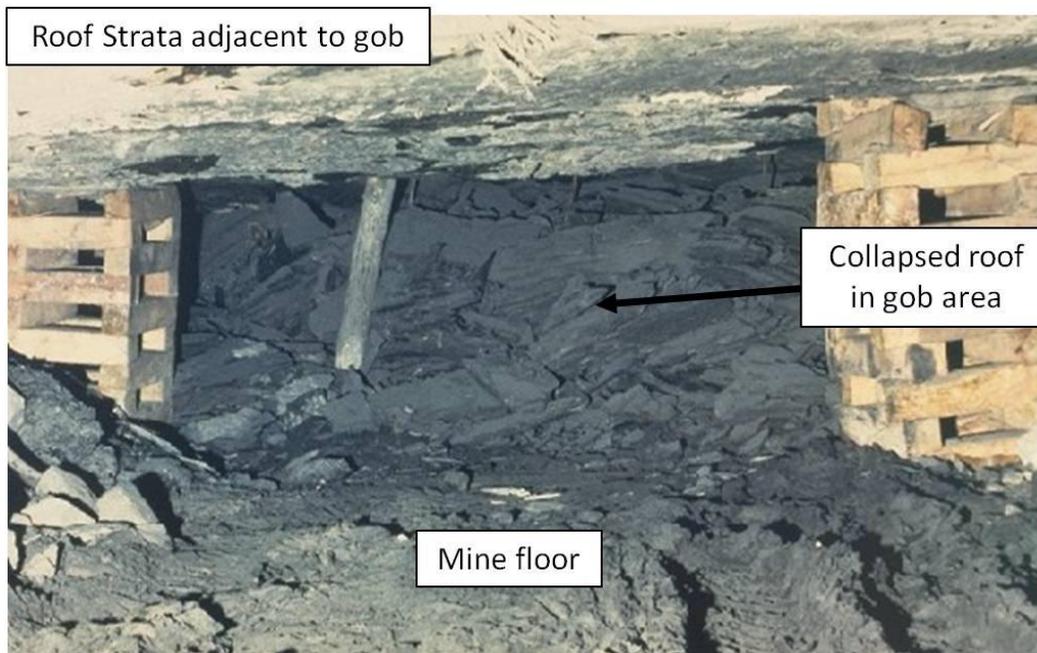
Figure I-7 - Example of full extraction mining at the VP No.3 Mine in Virginia. At this mine the roof rock collapses into the void created by the extraction of the longwall panel (photograph courtesy of A. Iannacchione).

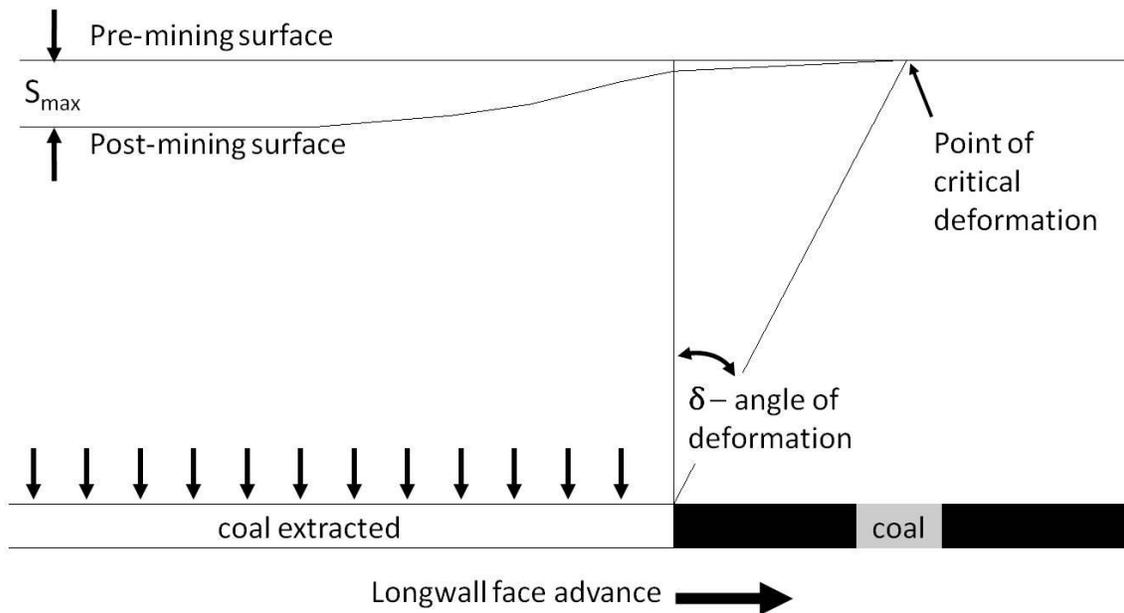
Figure I-8 - Generalized model showing how a subsidence basin forms in association with longwall mining.

As might be imagined, a subsidence basin forms as the coal is mined and the overlying strata are allowed to fail and collapse into the recently created void (Figure I-8). As the working face of the coal mine advances, the extraction zone increases in size. The composition and thickness of the overlying rock helps determine the subsidence basin that propagates on the surface in advance of the working face underground. The angle between the vertical line at the extraction zone edge and the line connecting the extraction zone edge and point of critical deformation on the surface is called the angle of deformation, or δ , (Peng and Geng, 1982) (Figure I-8).

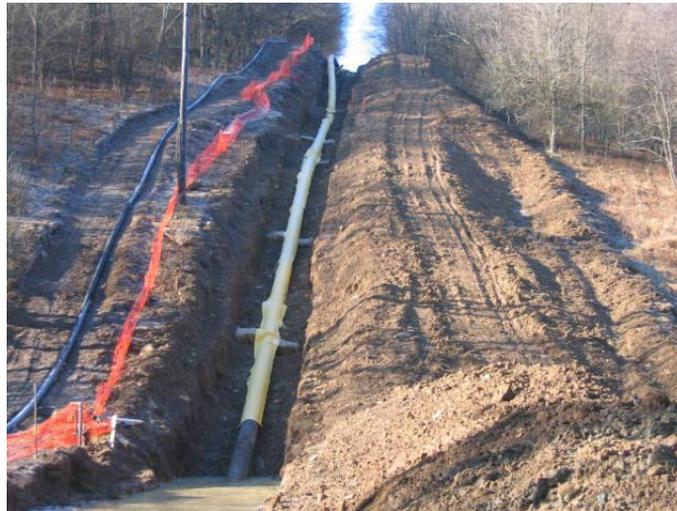
Figure I-10 - Gas pipelines are routinely excavated and temporarily supported to mitigate the impacts from longwall mining (Photograph from PA DEP files).

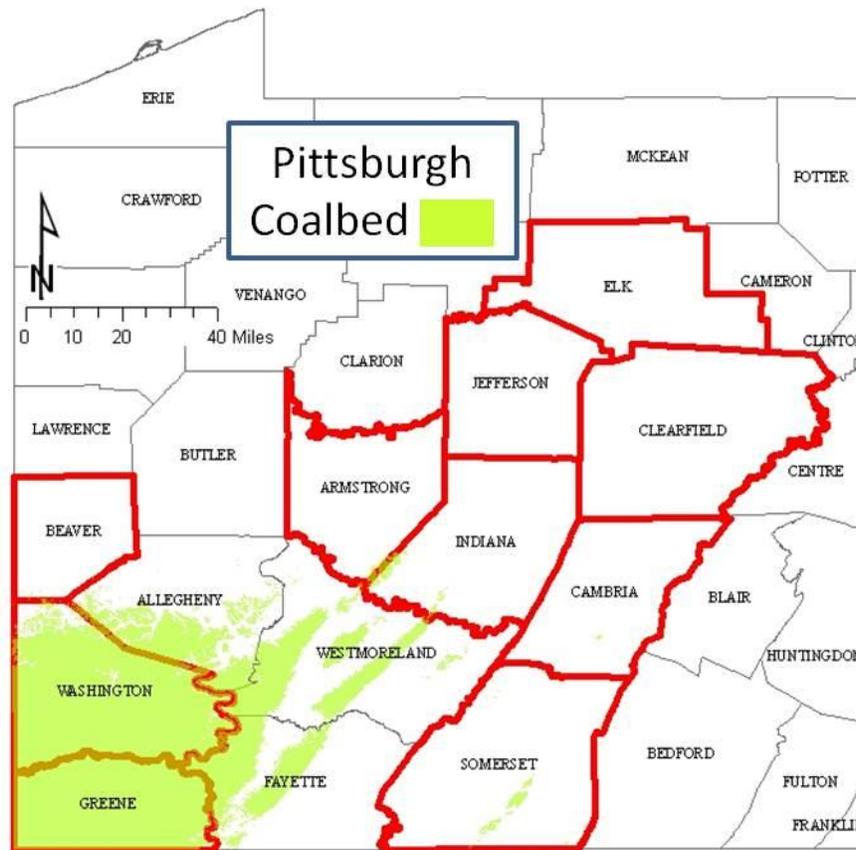
Figure III-6 - Areas underlain by the Pittsburgh Coalbed. Note - While current mining in the Pittsburgh Coalbed is largely limited to Greene and Washington Counties, drift and shaft mining have occurred in Allegheny, Armstrong, Fayette, Indiana, Somerset and Westmoreland Counties over the last 100 years.

Washington Counties where the coal is relatively continuous and, for the most part, relatively deep (400 to 2,000-ft). Allegheny, Fayette, and Westmoreland Counties also have continuous deposits of the Pittsburgh Coalbed, however, the shallow depth (< 400-ft) of the coal made it easily accessible for underground mining and it is now largely mined out.

In Armstrong, Indiana and Somerset Counties, the Pittsburgh Coalbed occurs in a few relatively small basins remote from the main group of Pittsburgh Coalbed mines that operated during the reporting period. Only one operation, the Ridge Mine in Armstrong County, mined in an isolated small pocket of yet un-mined Pittsburgh Coalbed with an overburden less than 200-ft.

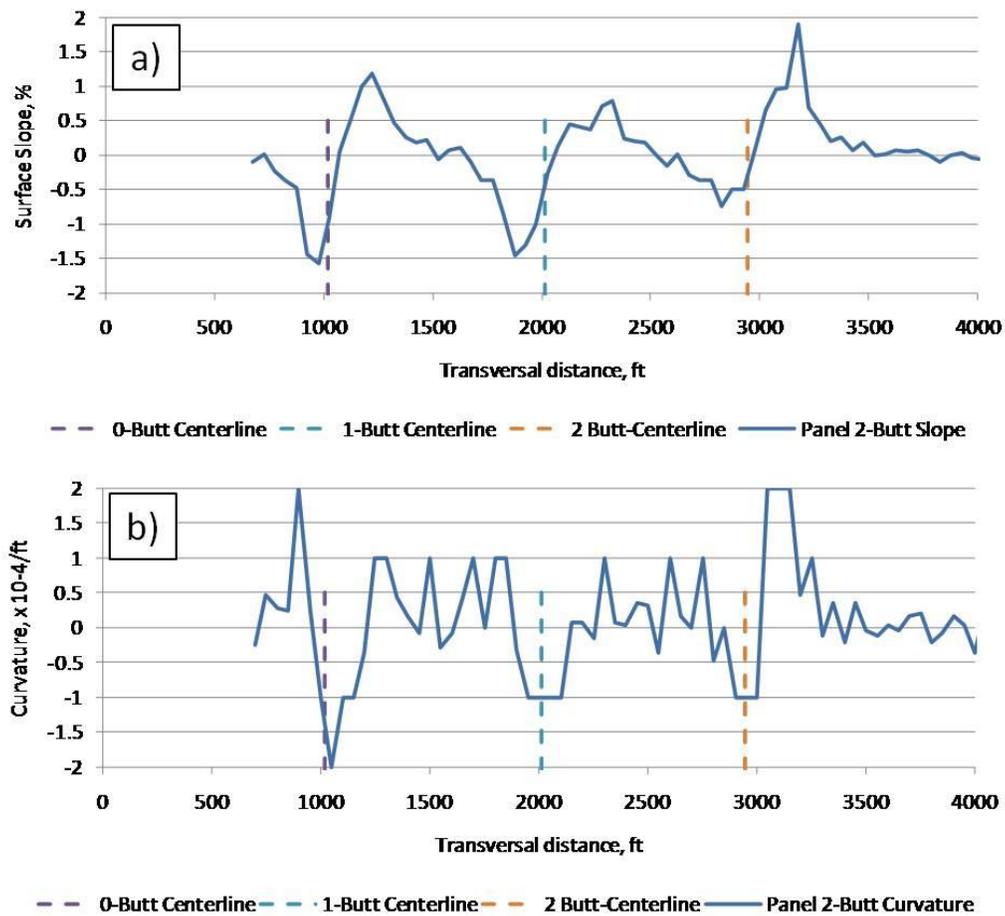
Figure IV-4 – Profiles of a) surface slope and b) curvature from three Gateway panels extracted under the northbound lanes of I79 (adapted from Yancich, 1986).

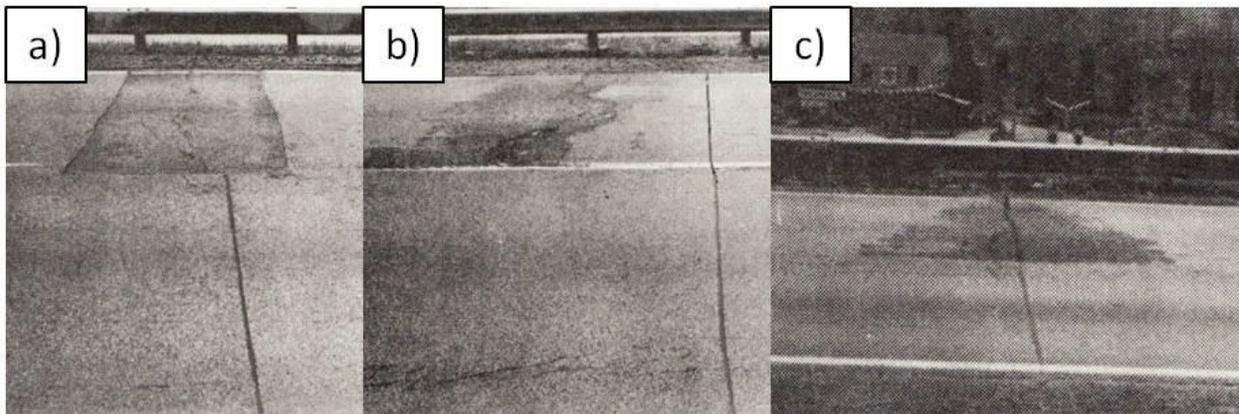
Figure IV-5 - Photographs of impacts to the northbound lanes of I79 over the 0-Butt (a), 1-Butt (b), and 2-Butt (c) panels of the Gateway Mine (Photographs from Yancich, 1986).

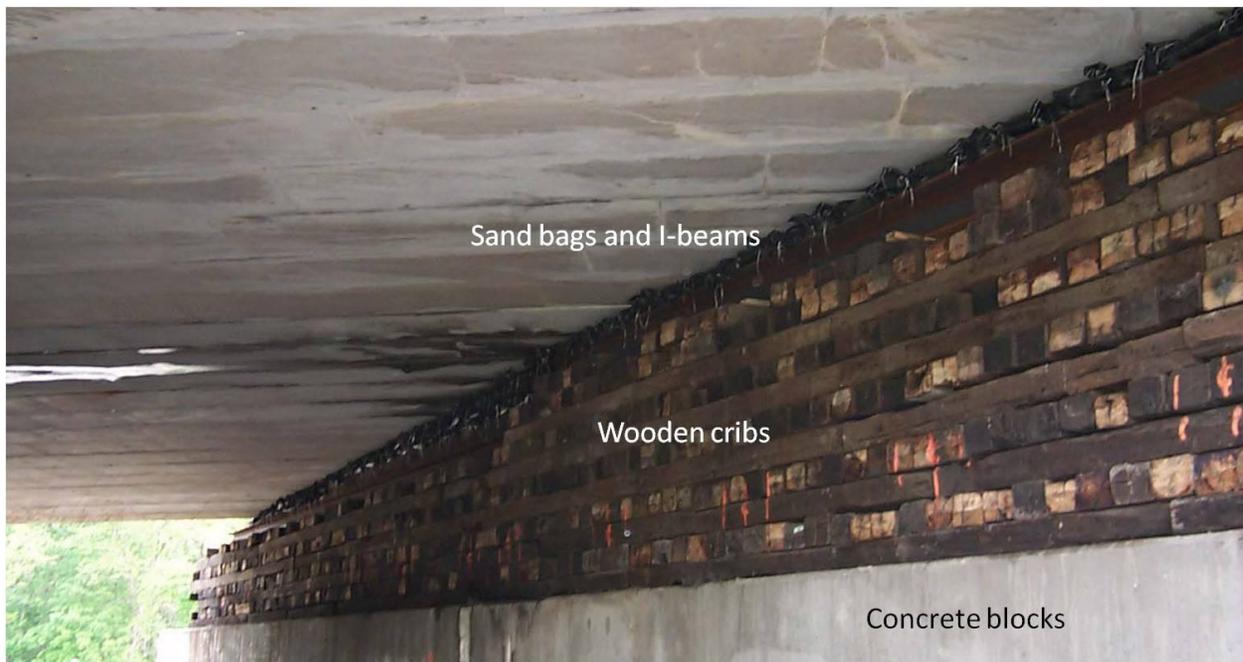
Figure IV-7 – Mitigation techniques used at the Zediker Station Road Overpass (Photograph from PA DEP files).

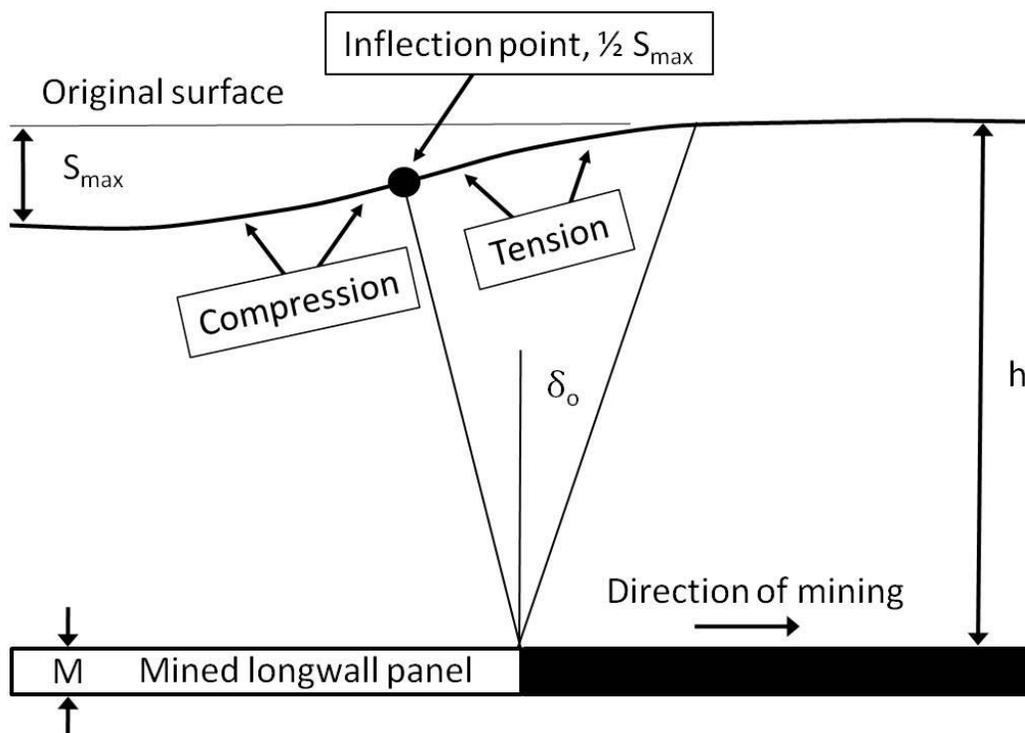
Figure IV-11 – Generalized relationship between vertical subsidence (S), h , δ_a , M and the occurrence of deformations caused by compression and tension.

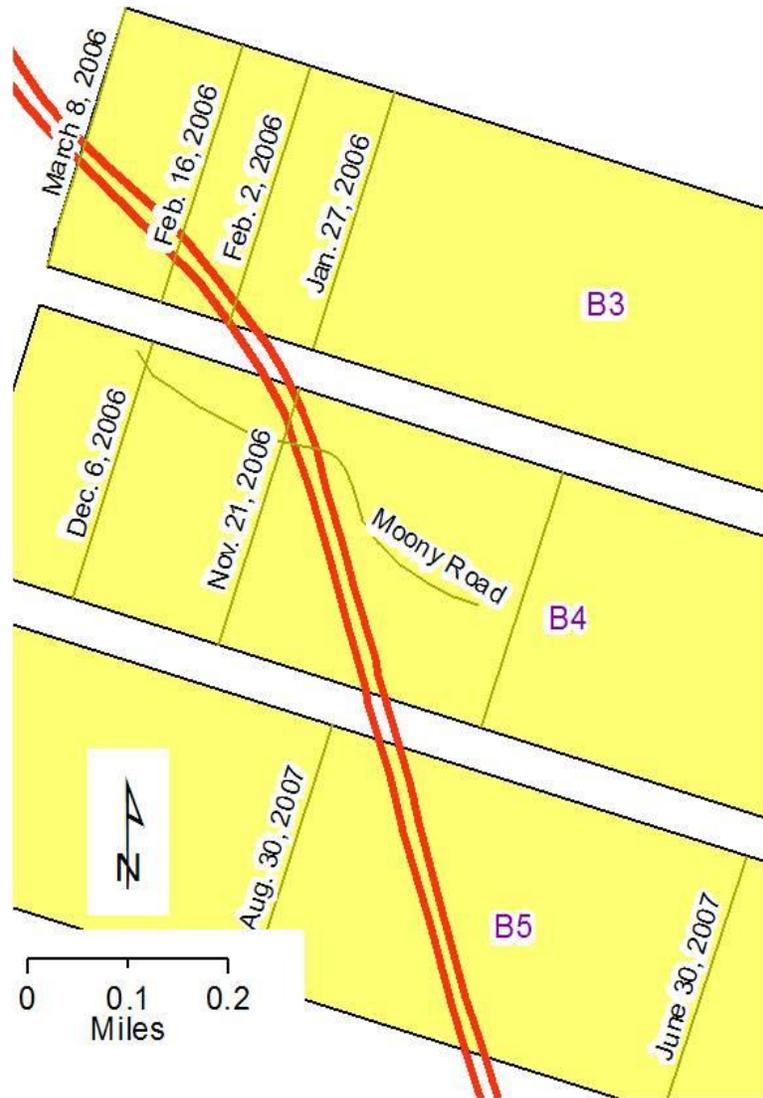
Figure IV-12- Locations of Emerald Panels B3, B4, and B5 with dated face positions during undermining of I79. Also shown is the section of Moony Road where it intersects I79.

Three Emerald panels impacted the overlying sections of I79 (Figure IV-12). The overburden at the area where I79 crossed these three panels ranged from approximately 700 to over 900-ft (Figure IV-12). I79 crossed all the Emerald panels at oblique angles ranging between 35 to 70-deg.

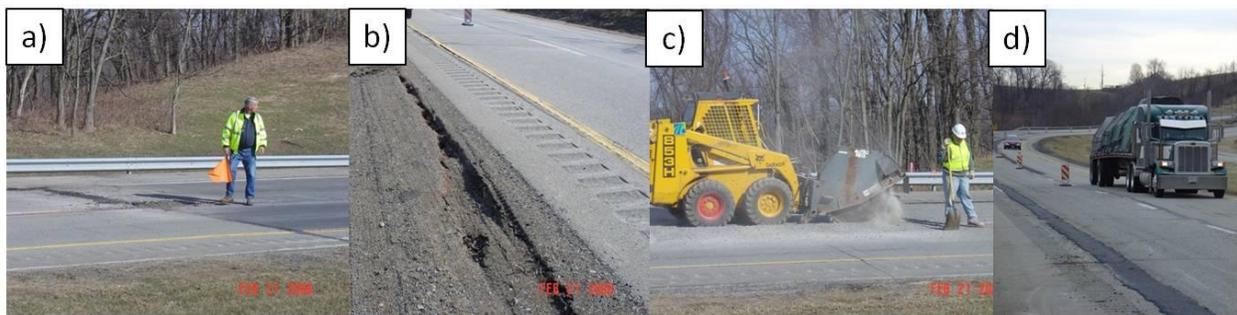
Figure IV-13 – Panel B3 photographs showing (a) a transverse compression heave, (b) lane-to-shoulder separation, (c) blowup compression bump being milled, (d) single lane restrictions with longitudinal patching, February 21, 2006 (Photographs from PA DEP files).

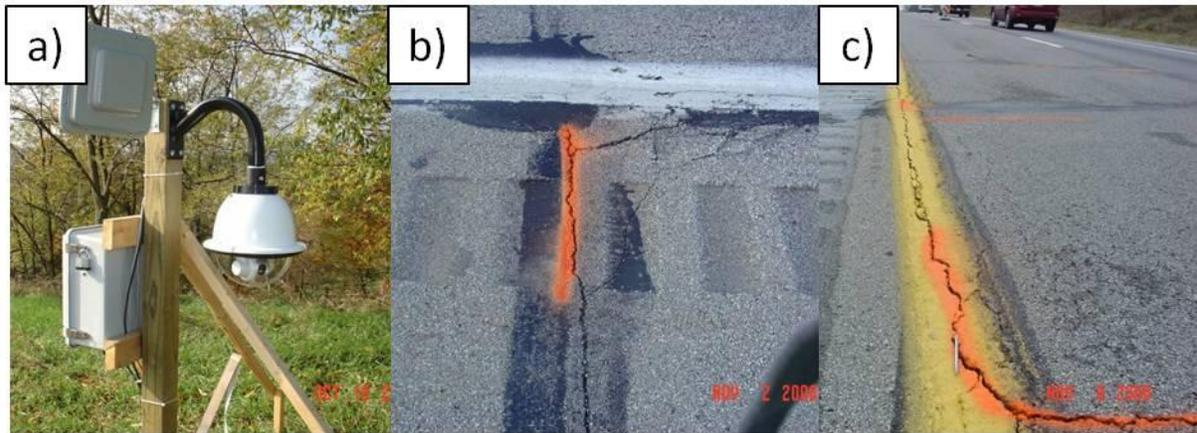
Figure IV-14 – Panel B4 Photograph showing (a) remote camera system, (b) transverse crack, and (c) longitudinal crack (Photographs from PA DEP files).

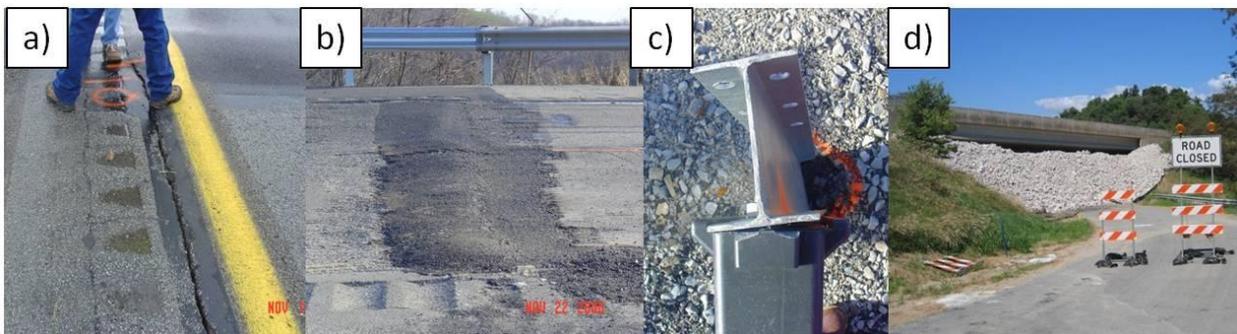
Figure IV-15 - Panel B4 photograph showing (a) lane-to-shoulder separation, (b) blowup, (c) distressed guard rails, and (d) mitigation method to protect I79 Bridge at Moony Road (Photographs from PA DEP files).

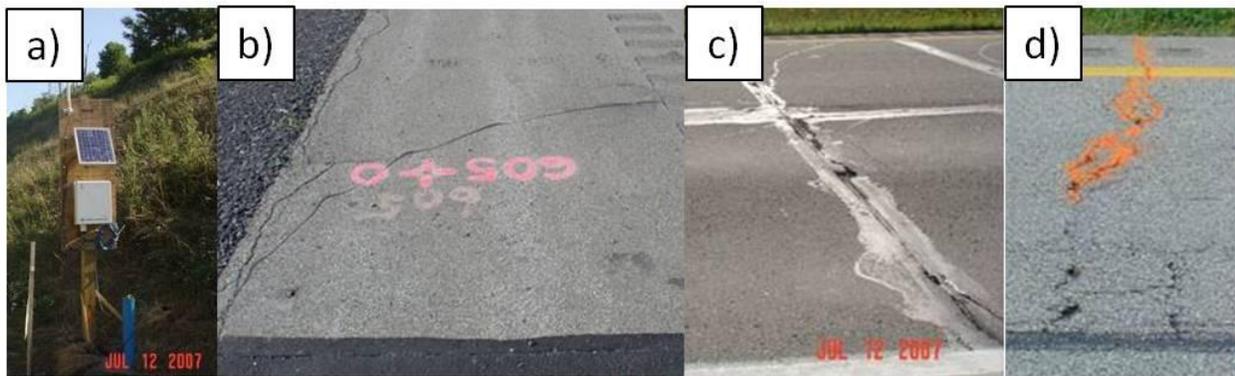
Figure IV-16 – Panel B5 photographs showing (a) data acquisition equipment, (b) corner breaks, (c) transverse joints, and (d) transverse cracks (Photographs from PA DEP files).

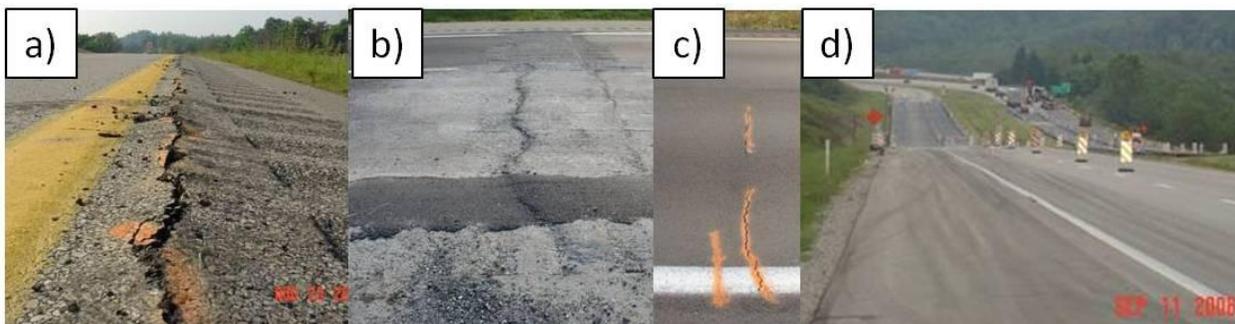
Figure IV-17 – Panel B5 photographs showing (a) lane-to-shoulder separation, (b) blowups, (c) transverse cracks, and (d) view of the final subsidence basin (Photograph from PA DEP files).

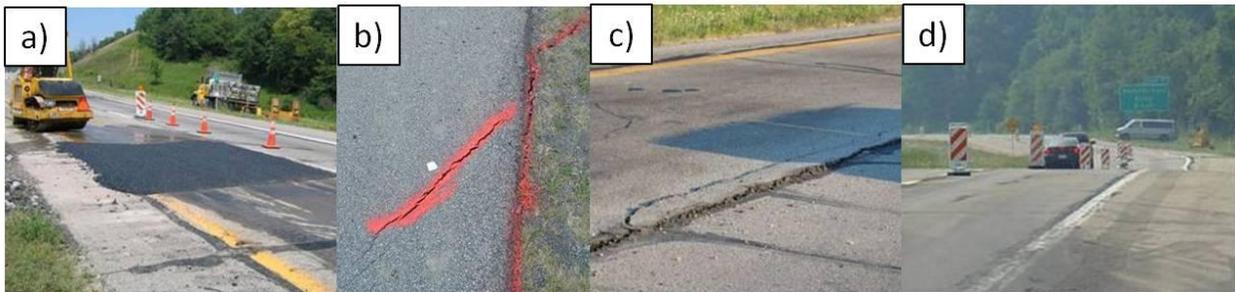
Figure IV-19 - Panel LW-50 photographs showing (a) patching activity, (b) a corner break, (c) faulting of joints, and (d) subsidence basin (Photographs from PA DEP files).

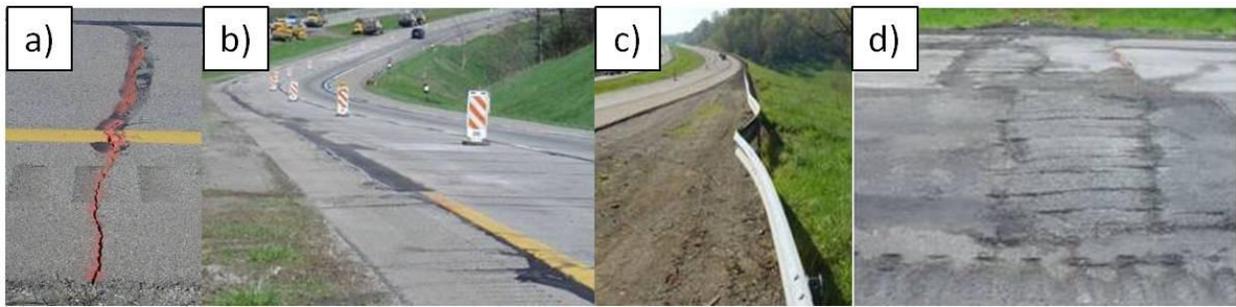
Figure IV-20 – Panel LW-51 photographs showing (a) spalling of transverse joint, (b) lane-to-shoulder separation, (c) compression of guard rail, and (d) blowup (Photographs from PA DEP files).

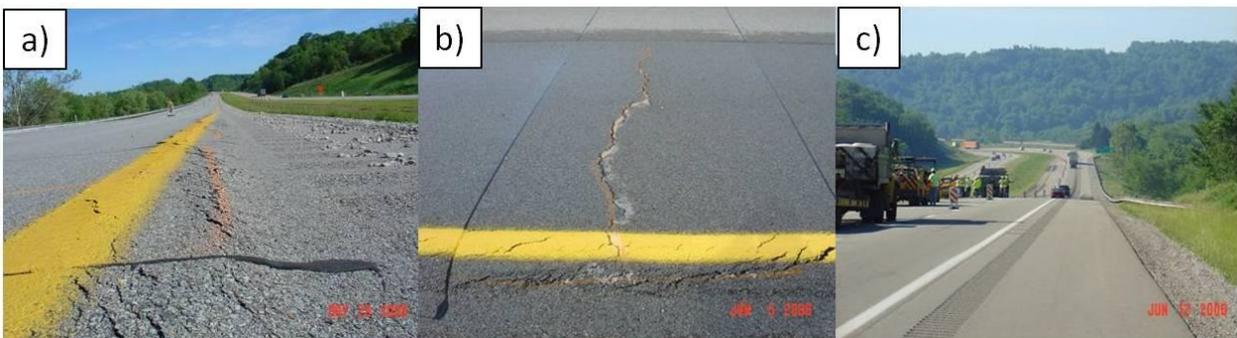
Figure IV-23 – Panel LW-54 photographs showing (a) lane-to-shoulder drop-off, (b) transverse and longitudinal cracking between saw cuts, and (c) final subsidence basin (Photographs from PA DEP files).

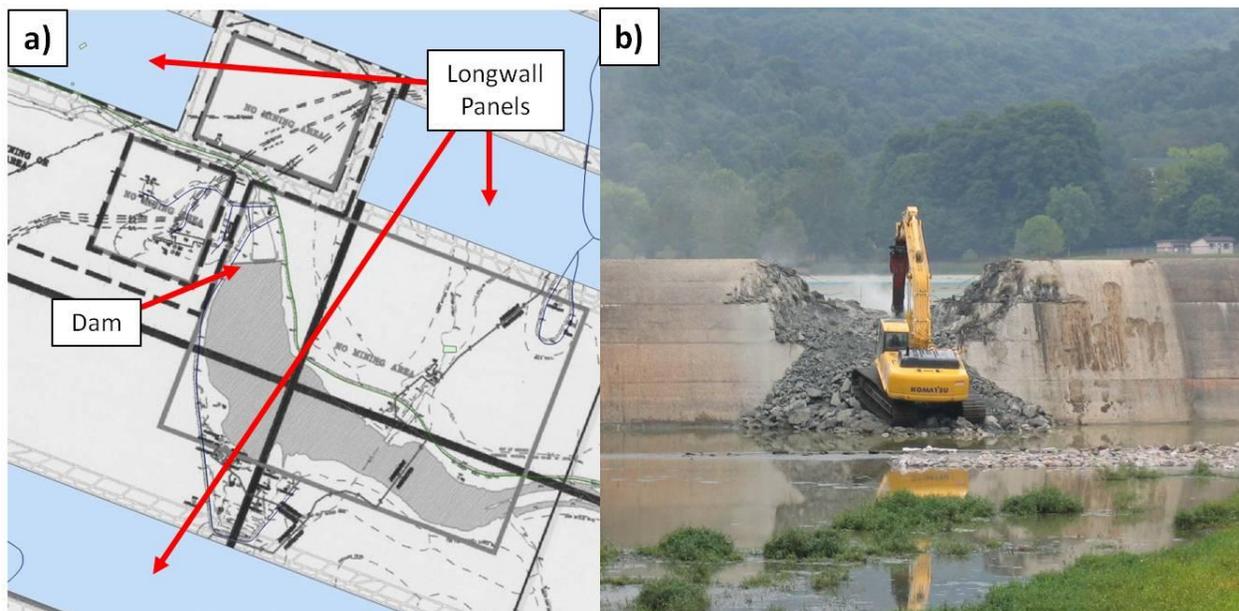
Figure V-2 – a) Map of the longwall panels in the vicinity of the dam and b) photograph of the dam in the act of being breached (Photograph from PA DEP files).

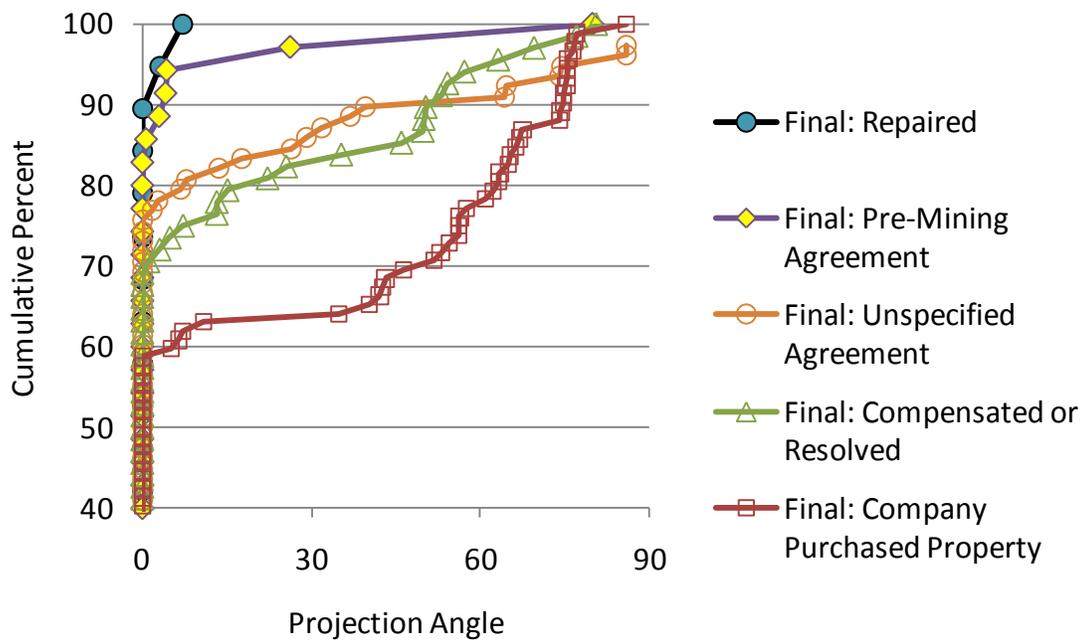
Figure V-7 – Relationship between projection angles and resolution category. Each data point represents the angle between the structure and the edge of mining.

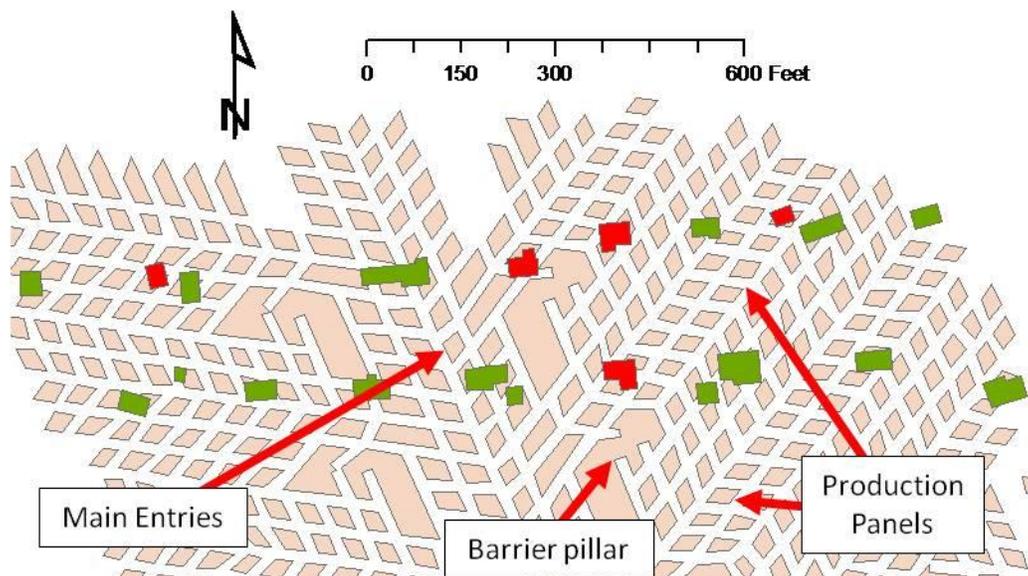
Figure V-8 – Area of the Clementine No.1 Mine where five structures with reported effects occur. This area contains main entries, production panels, and barrier pillars. Barrier pillars provide protection for the main entries. Note – Red = structures with reported effects, and Green = structures without reported effects.

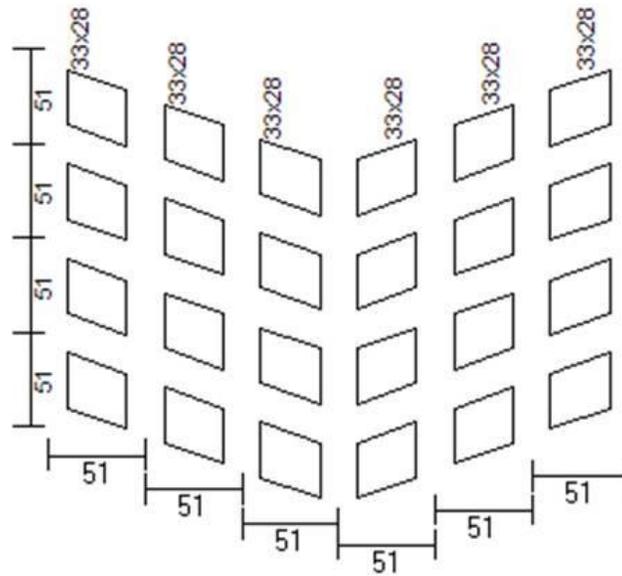
Figure V-9 – Mine layout used for Clementine No.1 ARMPS investigation.

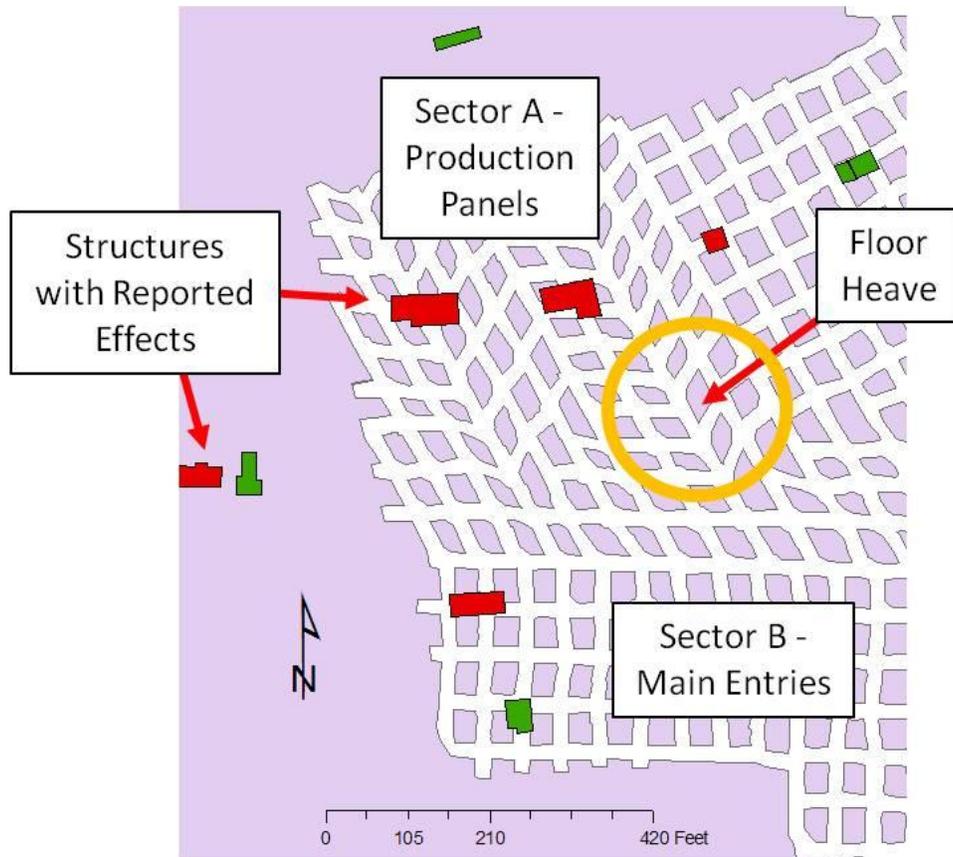
Figure V-10 – Area within the Ondo Mine where five structures with reported effects occurred within two distinct pillar layouts, A & B. Note – Red = structures with reported effects, and Green = structures without reported effects.

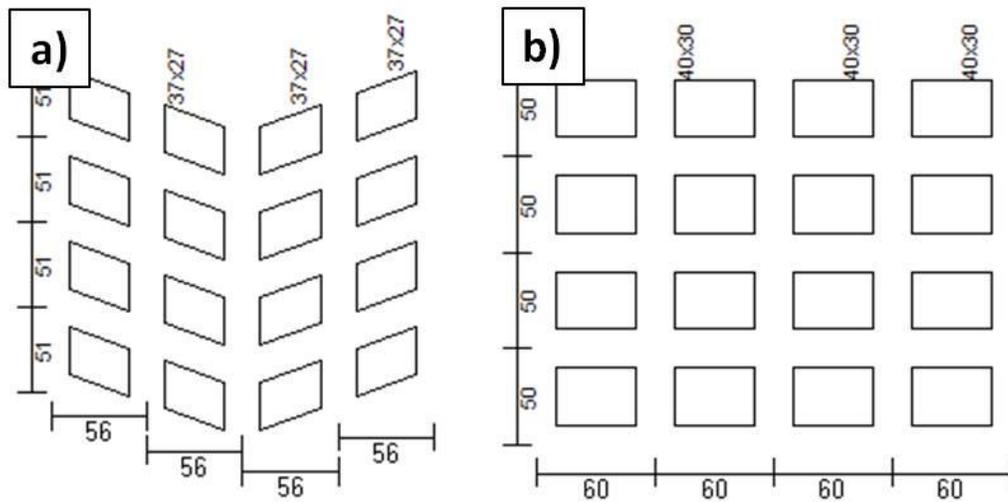
Figure V-11 – Two distinct mine layouts used in area where five structures reported effects at the Ondo Mine. Map a) Sector A with an extraction ratio of 65-pct, and b) Sector B with an extraction ratio of 60-pct.

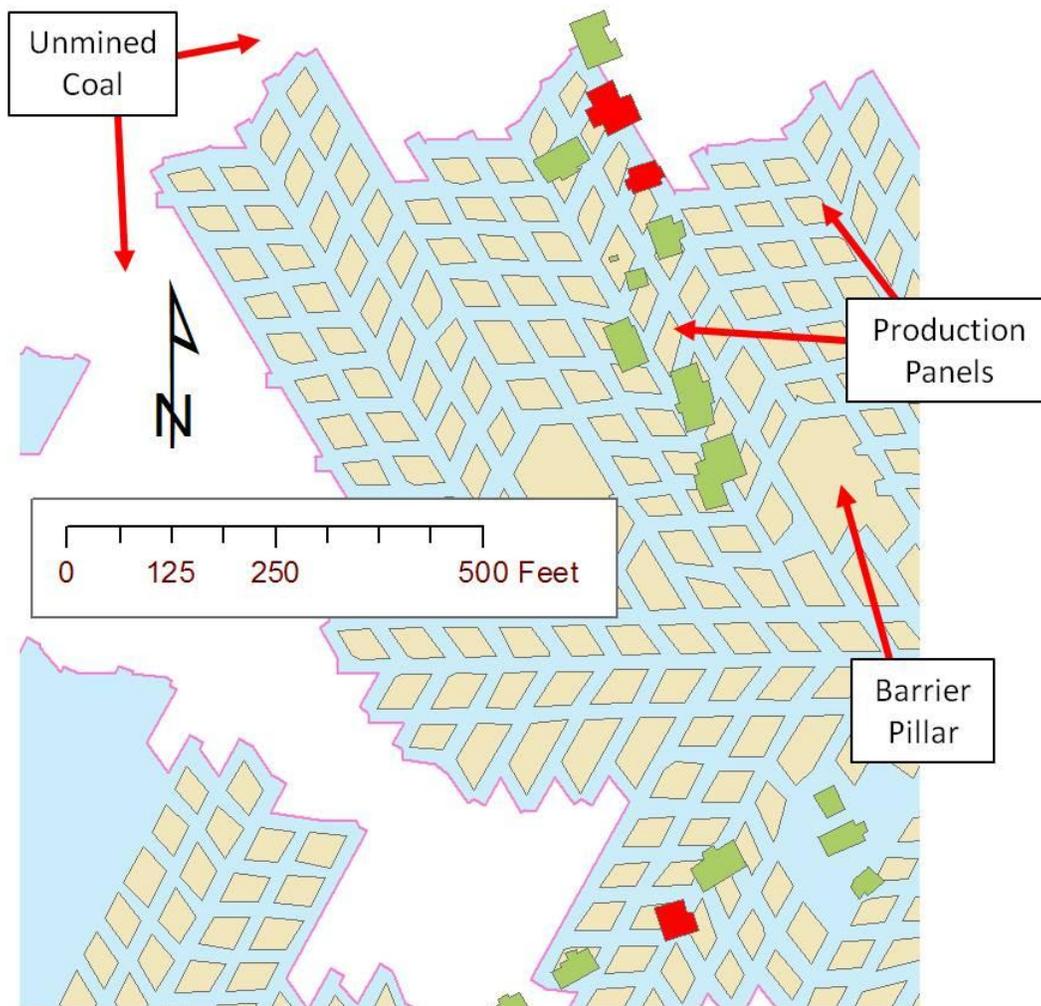
Figure V-12 - Section of the Tracy Lynne Mine where three structures with reported effects occurred. Note – Red = structures with reported effects, and Green = structures without reported effects.

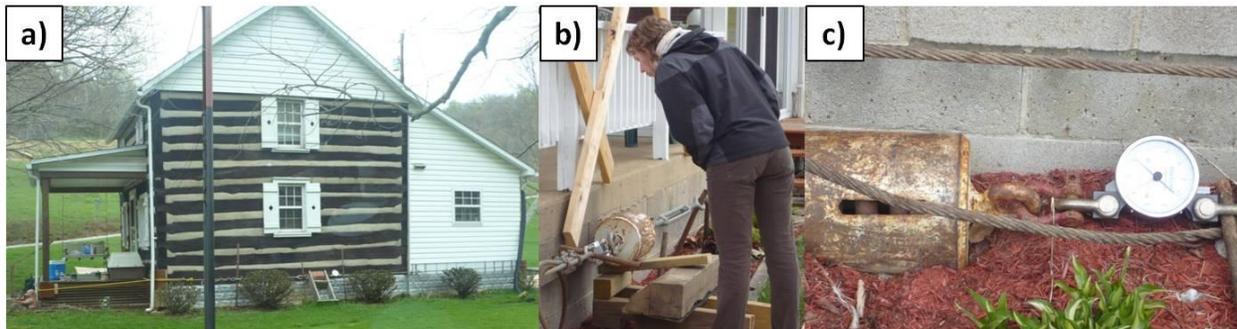
Figure V-13 - Photographs of a) residential structure with polypropylene rope around the foundation, b) steel cable spring and tension assembly, and c) spring and gage assembly (photographs courtesy of N. Iannacchione).

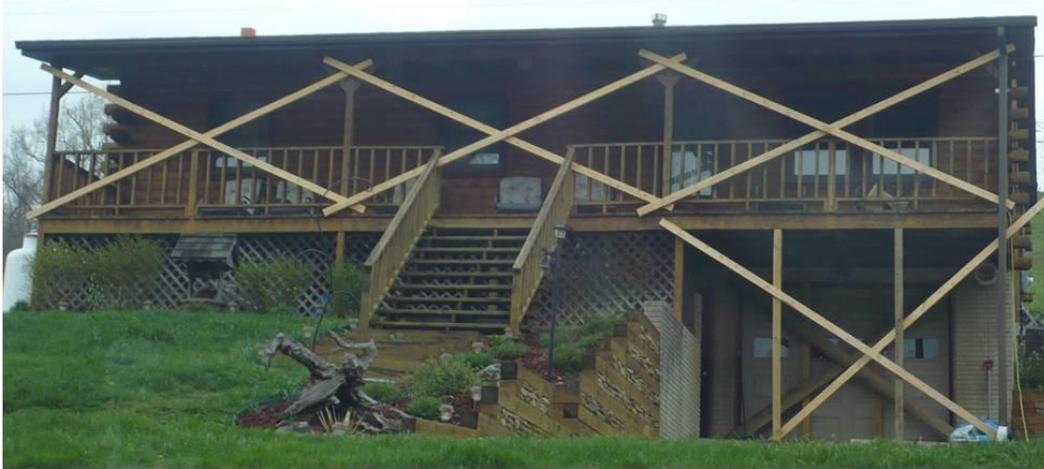
Bracing is typically applied to stiffen a structure. It does this through a supporting beam or a connecting wire or rope that steadies and holds the structure in the correct position against vertical and horizontal rotations. Bracing can be made of wood or metal. This measure is generally applied diagonally between intersecting components on the structure (Figure V-14)

Figure V-14 - Photograph of bracing (photograph courtesy of N. Iannacchione).

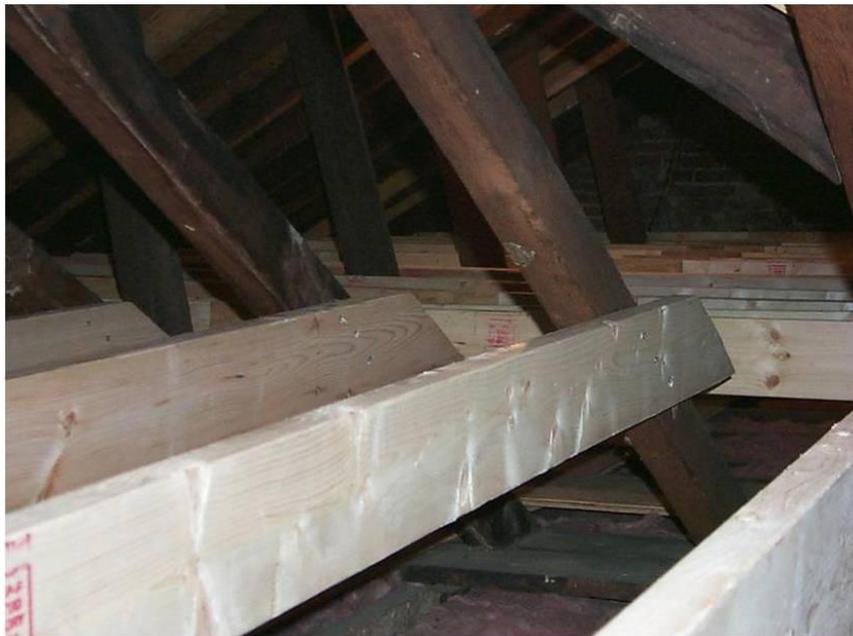
Bridging is used to strengthen and stiffen a structure against differential movement. It is generally applied within the attic of the structure (Figure V-15). Bridging reinforces levels within a structure, decreasing the impact of differential settlement. This can be an effective means of withstanding the passage of a subsidence wave propagating through a large structure.

Figure V-15 - Bridging applied to a structures attic to stabilize the roof (Photograph from PA DEP files).

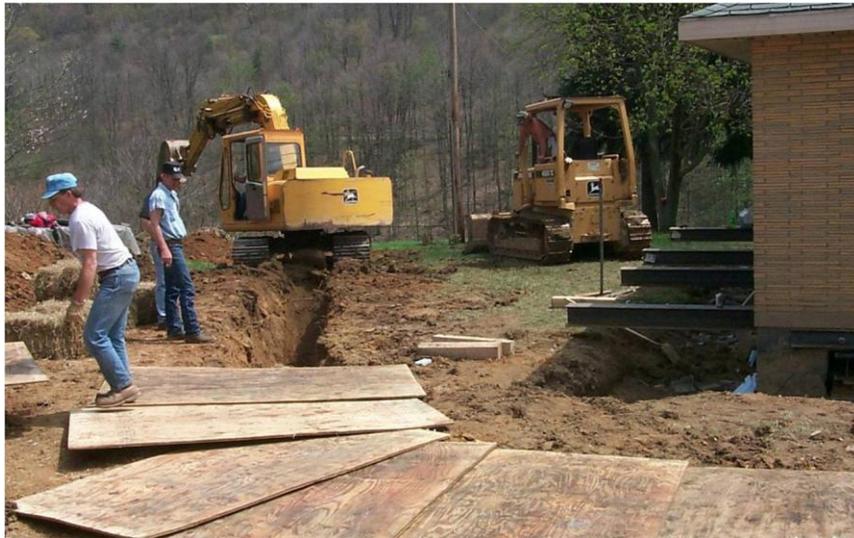
Figure V-16 - Photograph of a trench excavated adjacent to a structure to mitigate high horizontal strains (Photograph from PA DEP files).

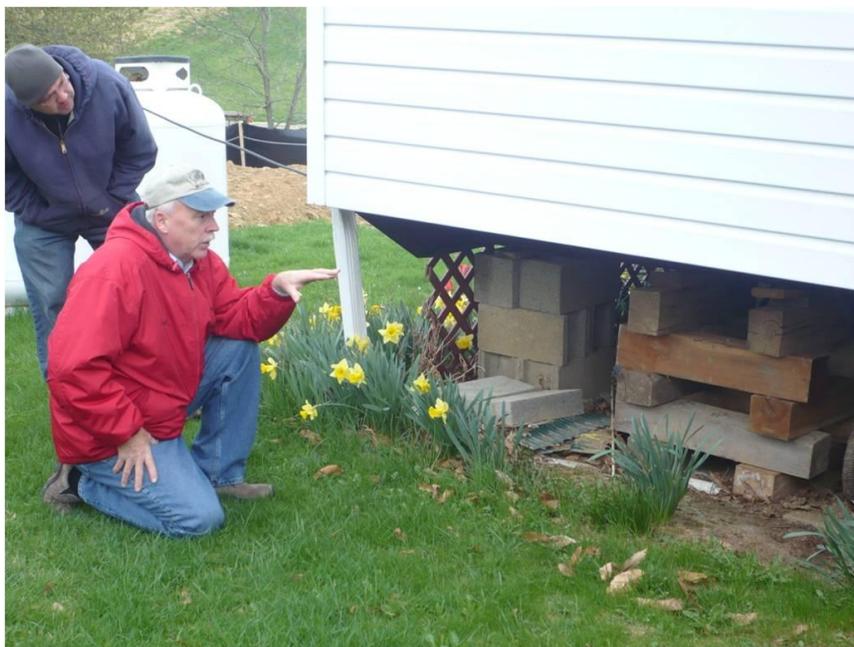
Cribbing is one of the most cost effective mitigation measures. In general, cribbing is used to arrest vertical movement within a structure (Figure V-17). Most cribs are constructed of wood and can withstand considerable vertical movement without losing their load bearing capacity. Wood cribs are not effective when significant horizontal movement occurs.

Figure V-17 – Photograph of cribbing (photograph courtesy of N. Iannacchione).

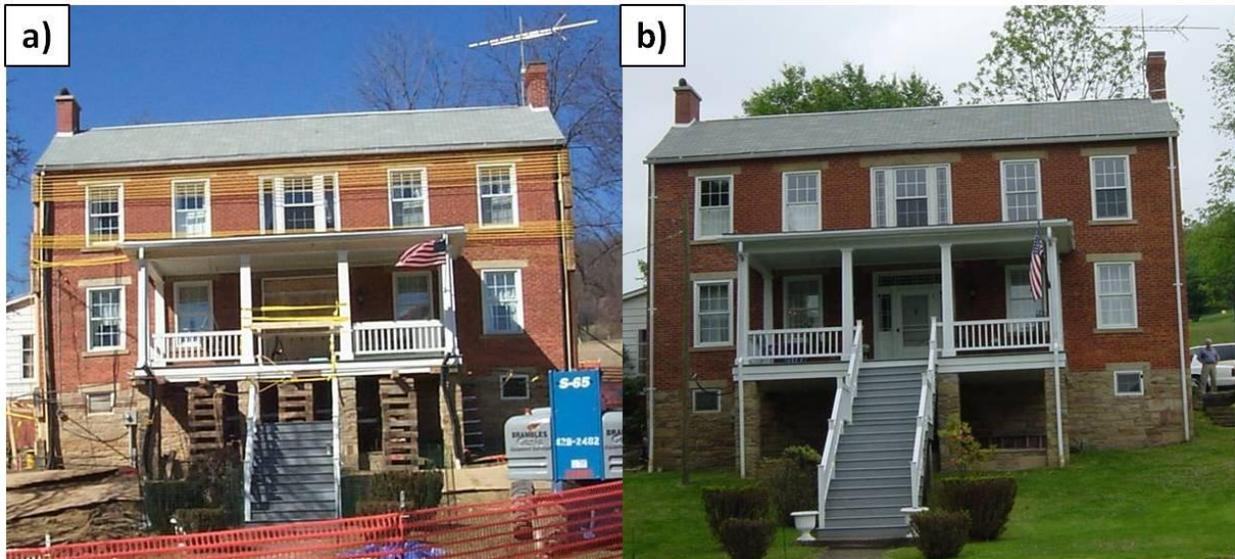
Figure V-18 – Photographs of a) historic farm house in 2001 treated with several mitigation techniques, i.e. banding, cribbing, and trenching and b) farm house on May 21, 2003 (Photograph from PA DEP files).
