The Effects of Subsidence Resulting from Underground Bituminous Coal Mining on Surface Structures and Features and on Water Resources, 2003 to 2008

Bituminous Mine Subsidence and
Land Conservation Act

ACT 54 Amendments
Five-Year Report
August 2003 to August 2008

Research Conducted by the University
of Pittsburgh for the Pennsylvania
Department of Environmental
Protection

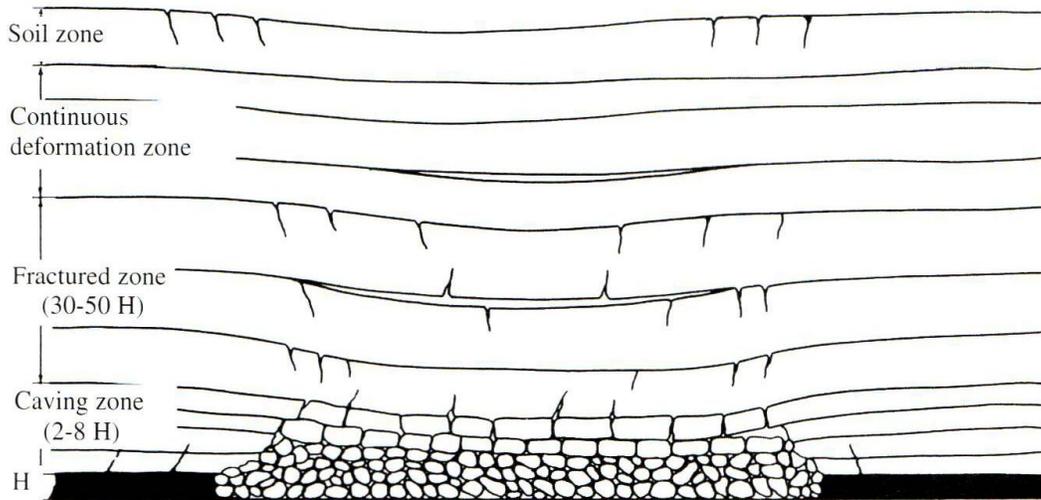
Figure VI-11 – Depiction of the four subsidence zones according to Peng (1992).

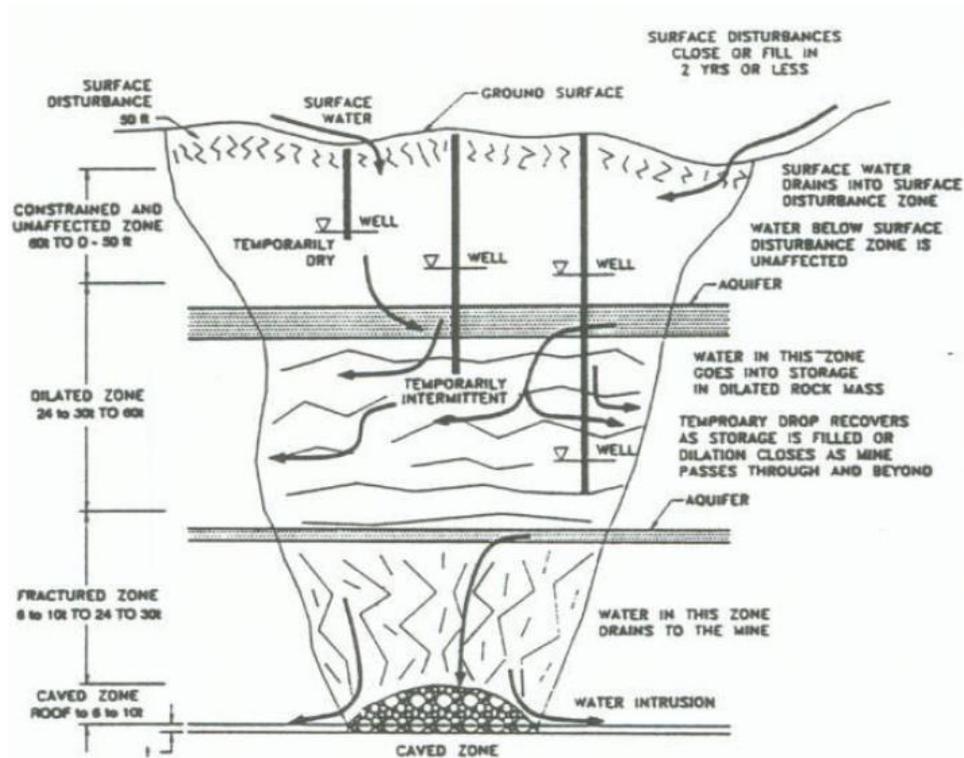
Figure VI-18 – Hydrologic response zone described by Kendorski (1993).

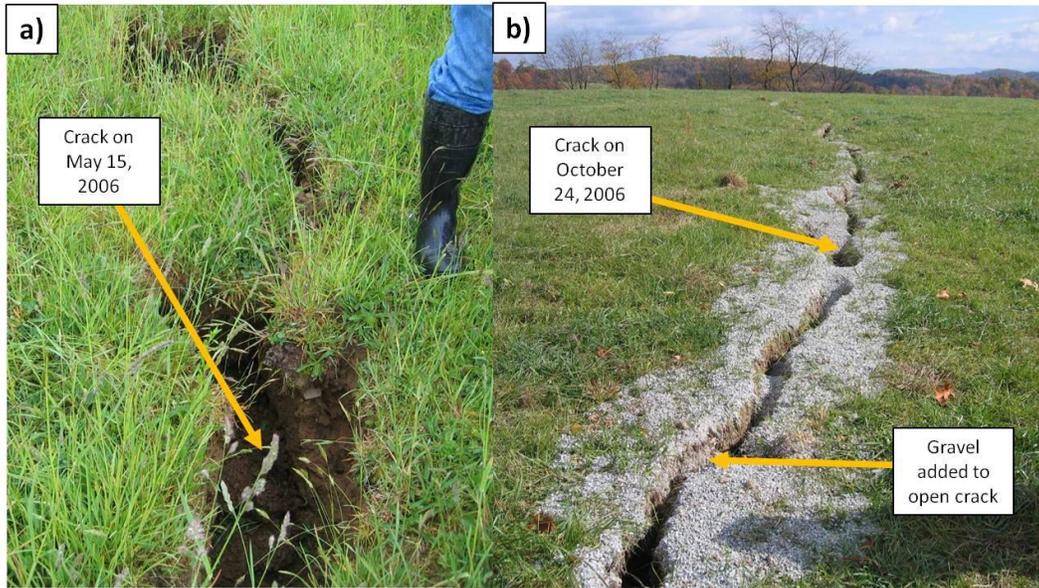
Figure VIII-2 – Photograph of large tension crack a) open shortly after the underlying longwall panel was mined, and b) partially repaired by filling with gravel and other aggregate products until the ground surface becomes level (Photographs from PA DEP files).

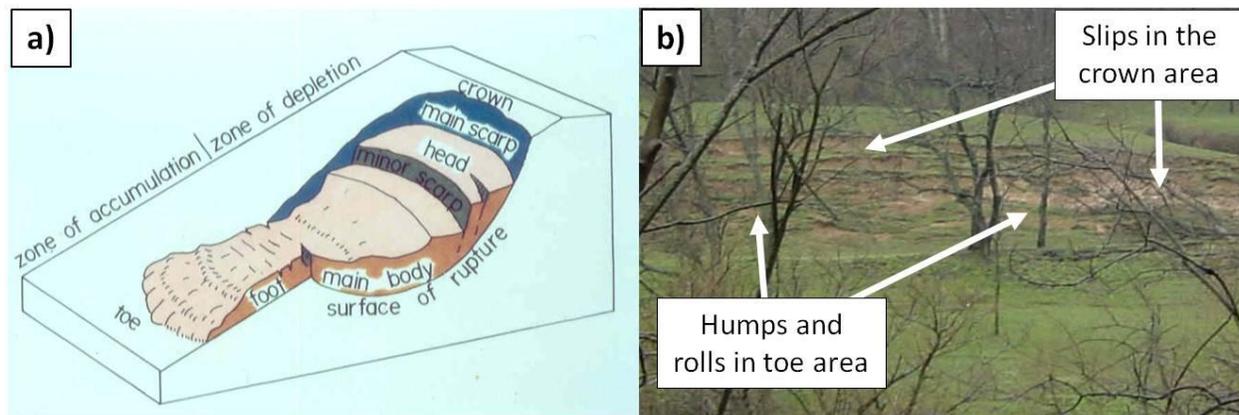
Figure VII-3 – a) General characteristics of mass wasting episodes taken from Varnes (1978) and b) large mass wasting event in Greene Co., PA (photograph from PA DEP files).

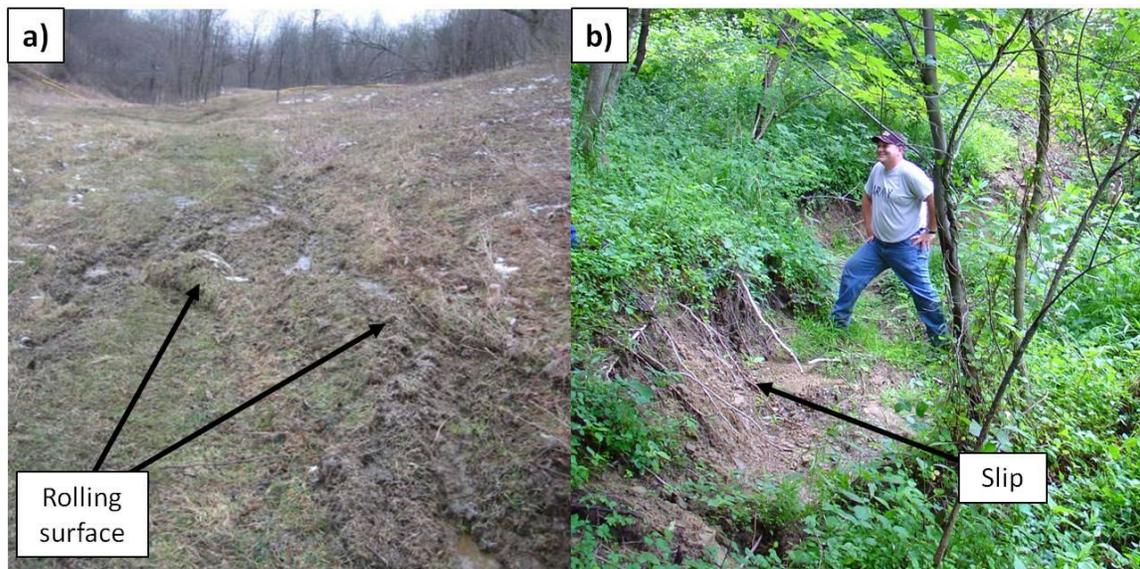
Figure VII-4 - Photographs of a) rolling surface and b) slip (Photographs from PA DEP files).

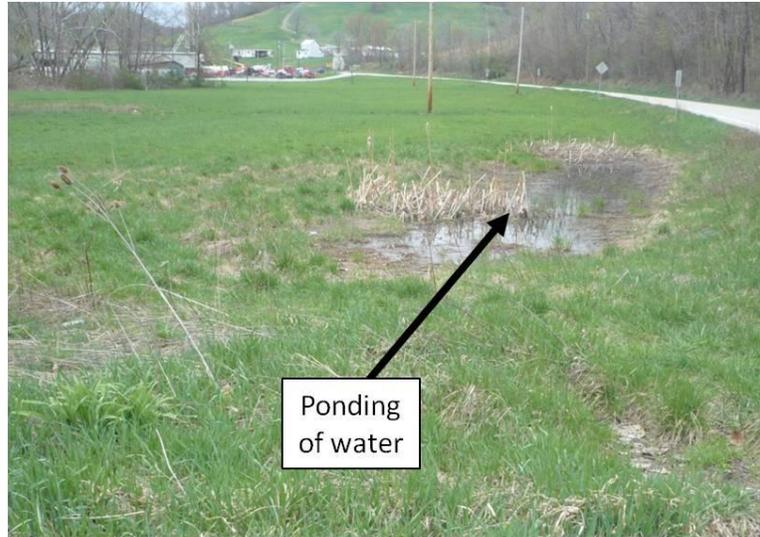
Figure VII-5 - Ground settlement over a longwall panel allowed water to pond in depression (Photograph courtesy of N. Iannacchione).

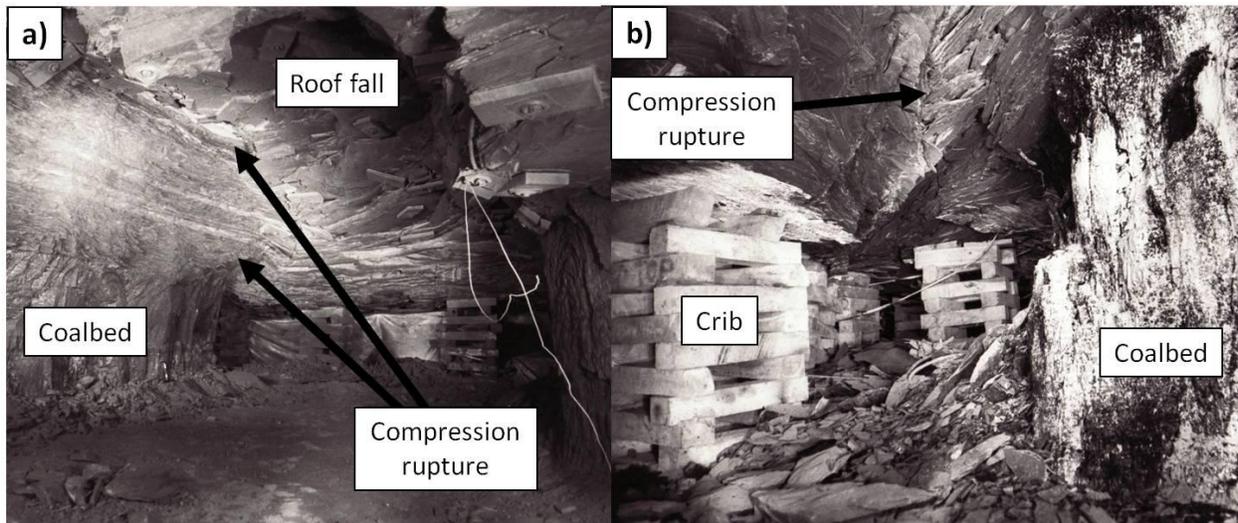
Figure VIII-6 - Photographs of compression ruptures a) along the side of a roof fall and b) close up within the roof-rib intersection area, Kitt Mine, northern West Virginia (photograph courtesy of A. Iannacchione).

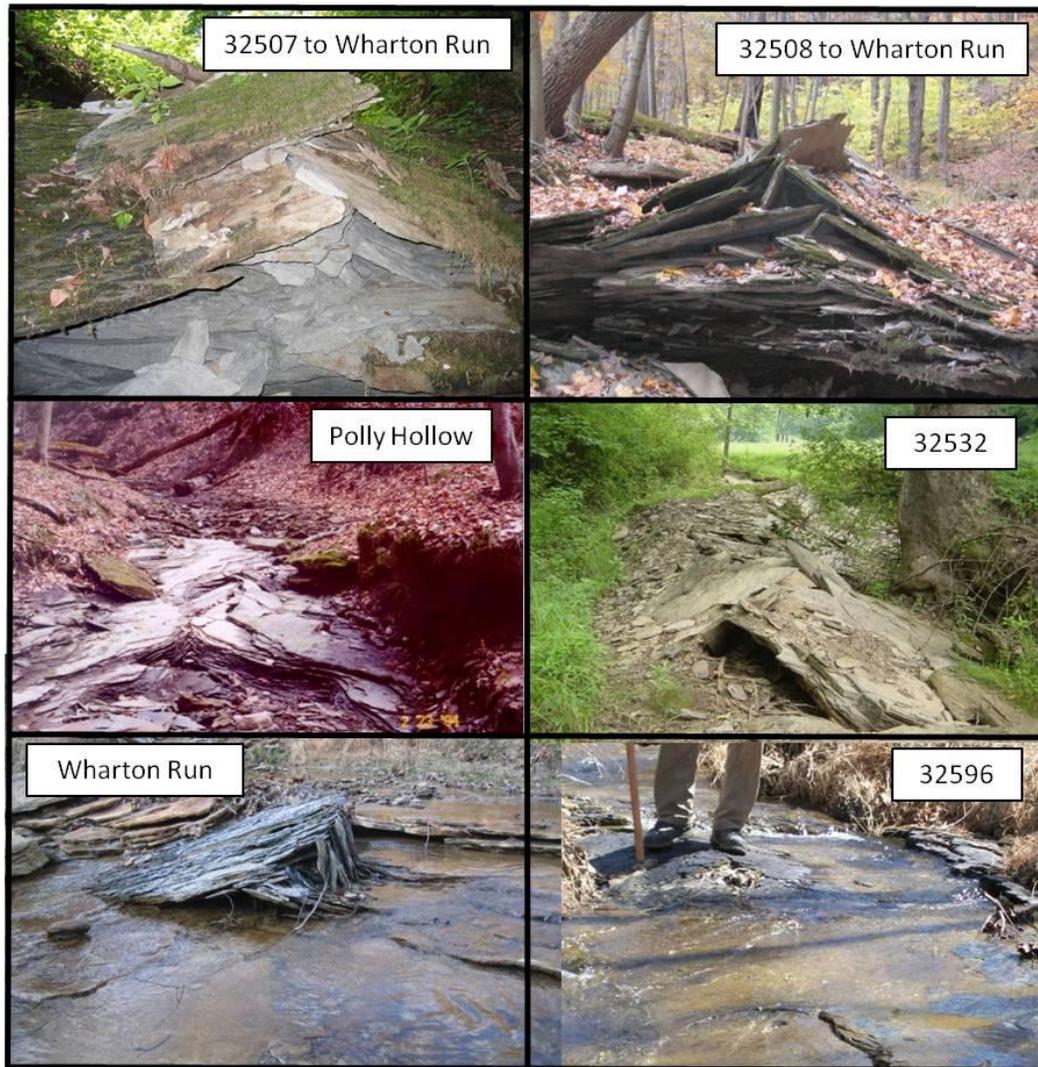
Figure VII-7 –Photographs of compression ruptures found in stream beds over the Bailey Mine (Photographs from PA DEP files).

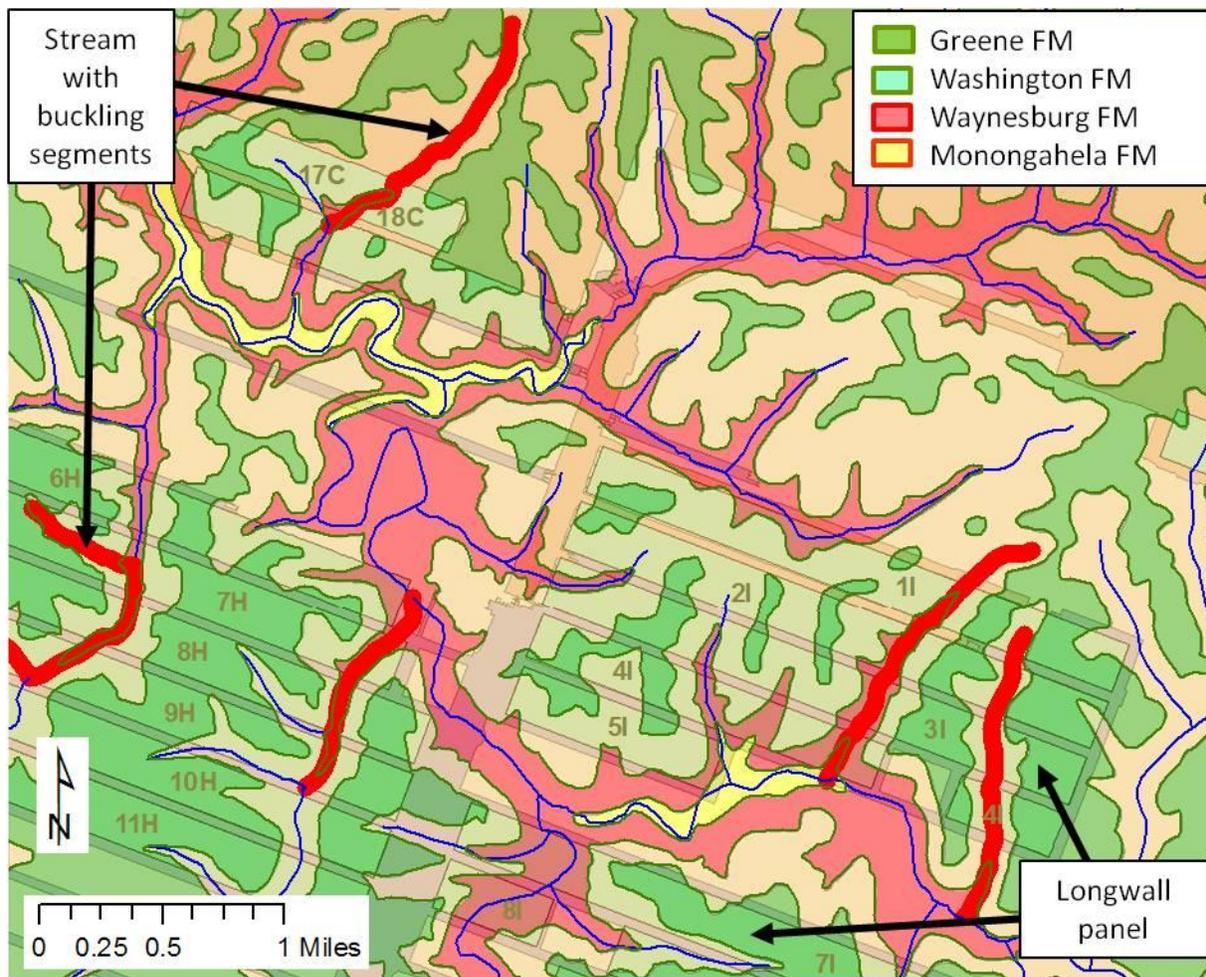
Figure VII-8 – Location of stream segments with compression rupture (thick red lines) above the Bailey Mine. Rock formations outcrop areas are also shown: Greene FM, Washington FM, Waynesburg FM, and Monongahela FM.

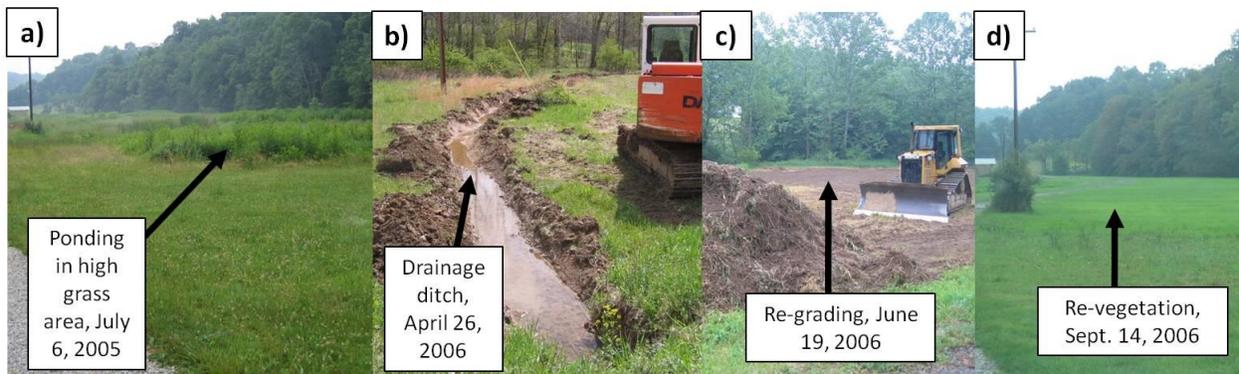
Figure VII-11 – Photographs of a commonly used method to repair settlement impacts after ponding resulted within a field or pasture (Photographs from PA DEP files).

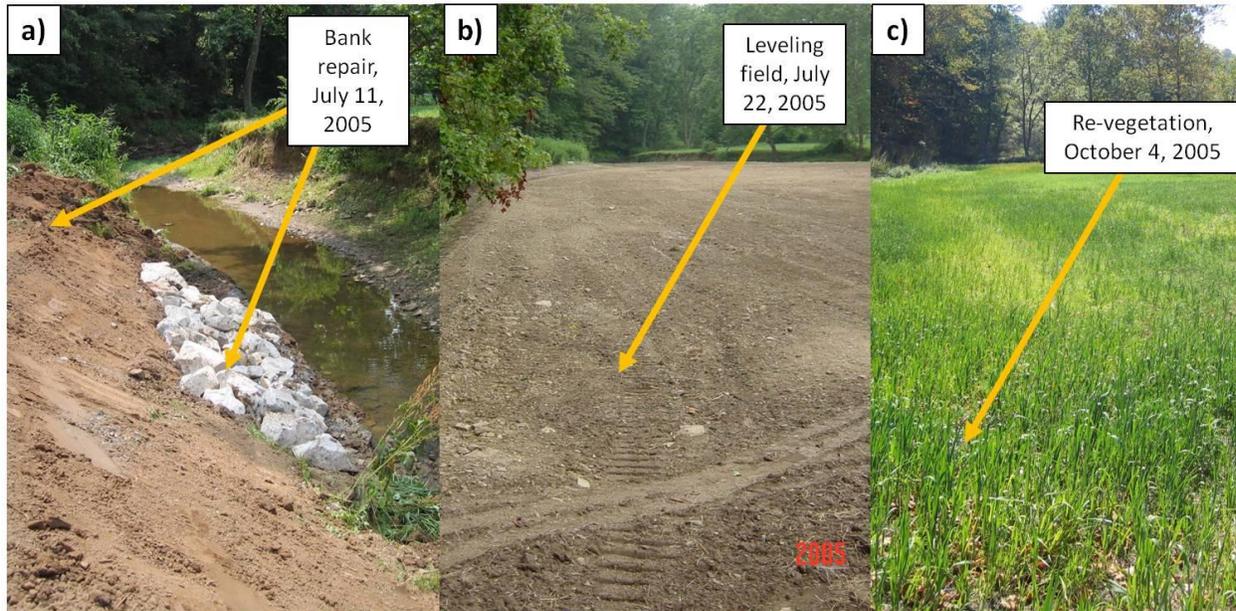
Figure VII-12 – Photographs of a common repair technique for settlement impacts adjacent to streams that caused ponding within a field or pasture (Photographs from PA DEP files).

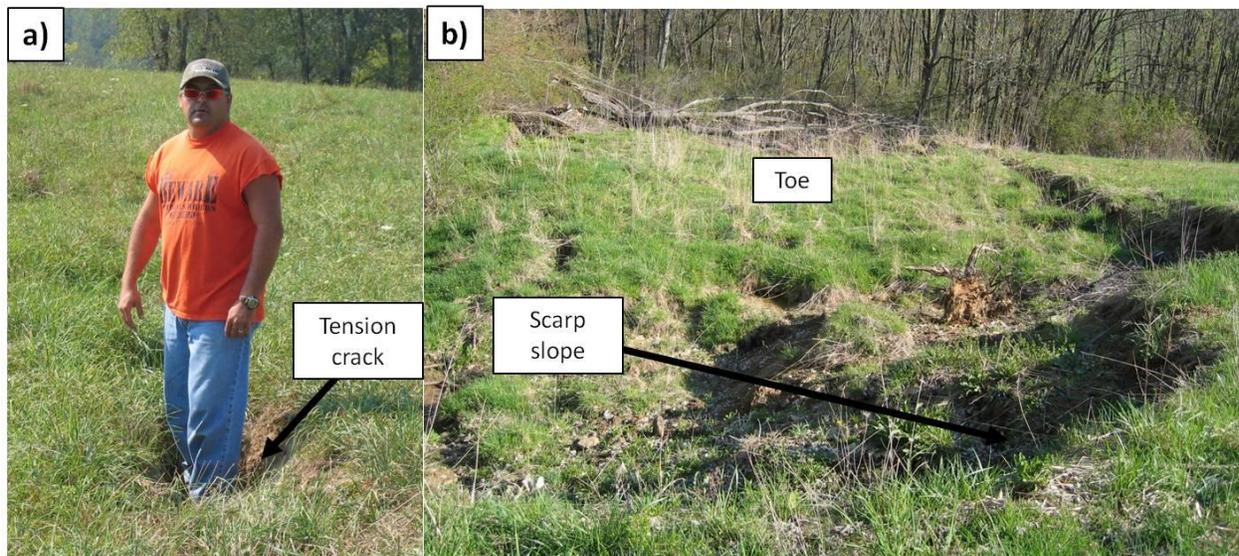
Figure VII-14 - Photographs of a) tension crack and b) mass wasting impacts to the surface. The first is a reported effect and the second is not (Photograph from PA DEP files).

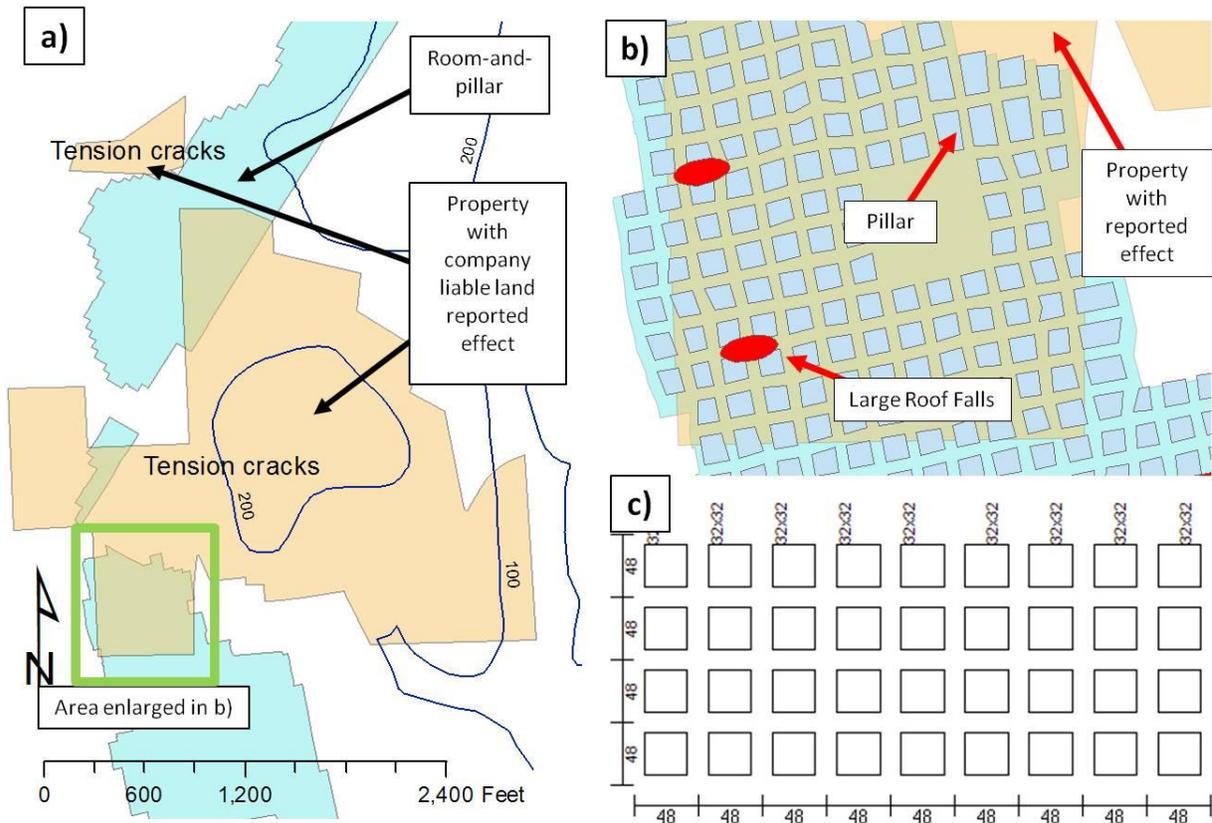
Figure VII-19 - Location of a) properties with land reported effects where the Ridge Mine is liable, b) pillar layout beneath the property where tension cracks were observed and roof falls noted on the 6-month mining maps, and c) ARMPS pillar layout characteristics.

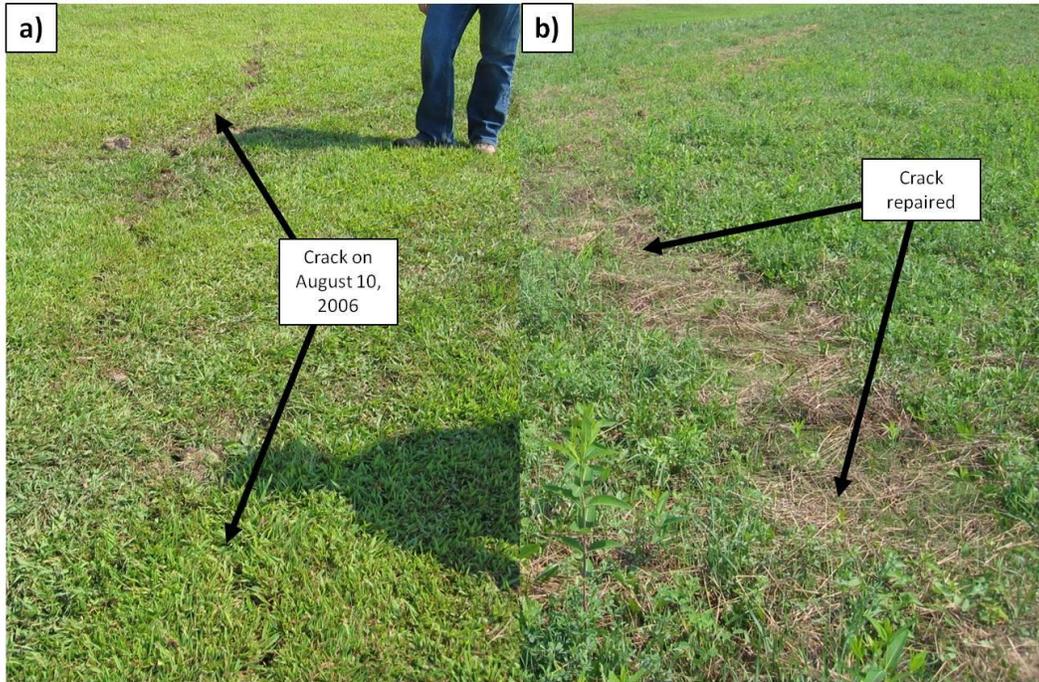
Figure VII-20 - Photographs of a) crack on August 10, 2006 and b) repair of a previous crack at the Ridge Mine (Photographs from PA DEP files).

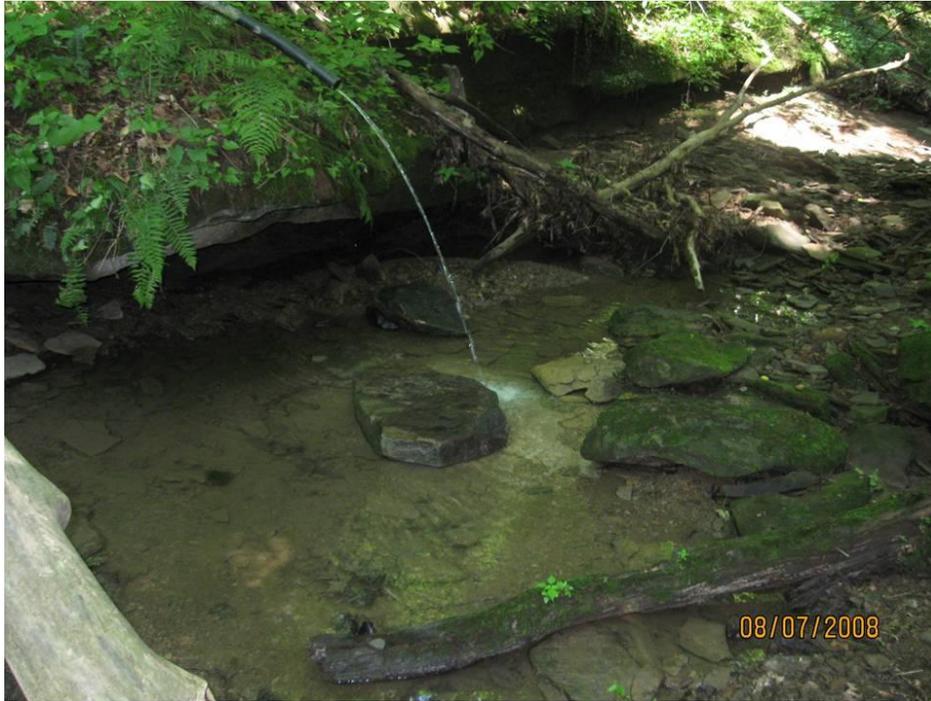
Figure VIII-1 - An augmentation line supplying temporary flow to stream 32508 over Bailey Mine (Photograph from PA DEP files).

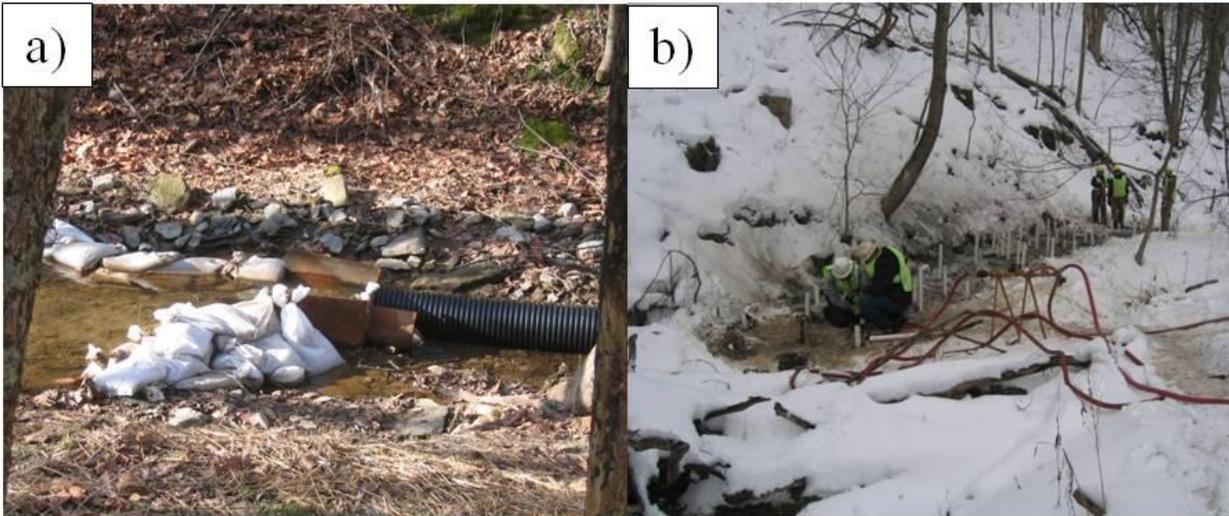
Figure VIII-2 - Grouting operation procedures. First, a) stream flow must be collected and diverted around the area where grouting will occur - shown at stream 32532 in Bailey Mine and then b) boreholes are drilled and clay pumped into fractures - shown at stream 32740 in Enlow Fork Mine (Photographs from PA DEP files).
